Frank M. Ligon
Director
Service Engineering Operations
Ford Customer Service Division

December 2004

SUBJECT: **Safety Recall 04S20: Supplement #2**
All 2002 and Certain 2003 Model Year Ford 4-Door Explorer & Mercury Mountaineer Vehicles - Liftgate Glass Hinge and Ball Stud Bracket (if applicable) Replacement

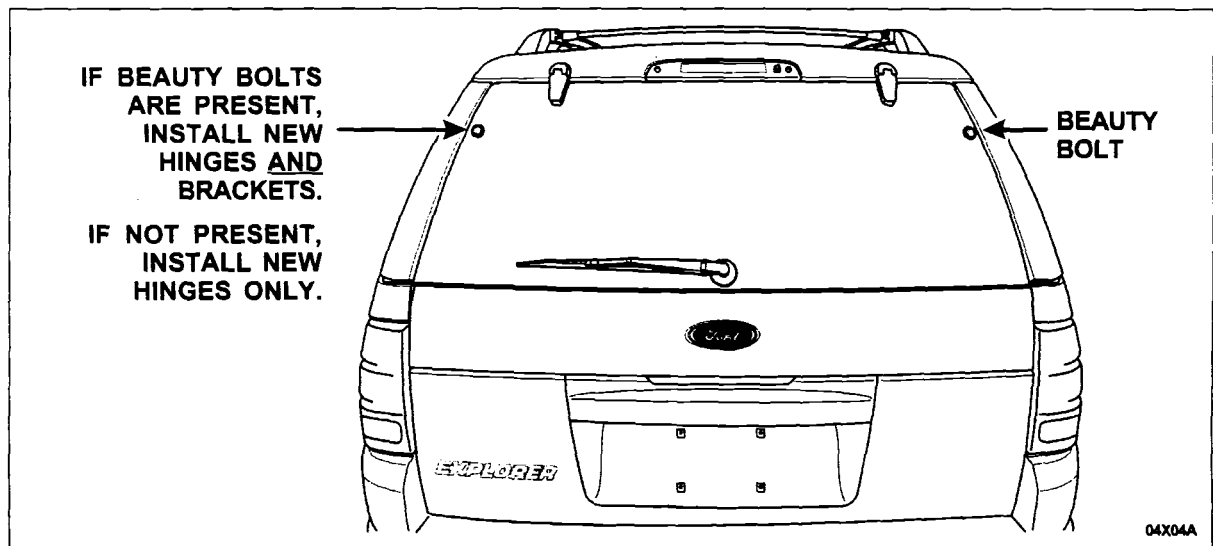
FIGURE 1

- Early 2002 models use ball stud brackets that are secured with beauty bolts, which pass through the glass (the head of the bolt is visible on the outside of the glass) and are bonded to the glass about 150 mm (6 inches) from the top of the glass. See Figure 1. If beauty bolts are present, both the liftgate ball stud brackets and hinges will be replaced. Perform **BOTH** the Liftgate Glass Hinge Replacement and the Ball Stud Bracket Replacement. Begin your repairs with LIFTGATE GLASS HINGE REPLACEMENT.
- Later built 2002 and 2003 model year vehicles use revised ball stud brackets which are not secured with beauty bolts. If beauty bolts are not present, only the hinges will be replaced. Perform only the LIFTGATE GLASS HINGE REPLACEMENT.

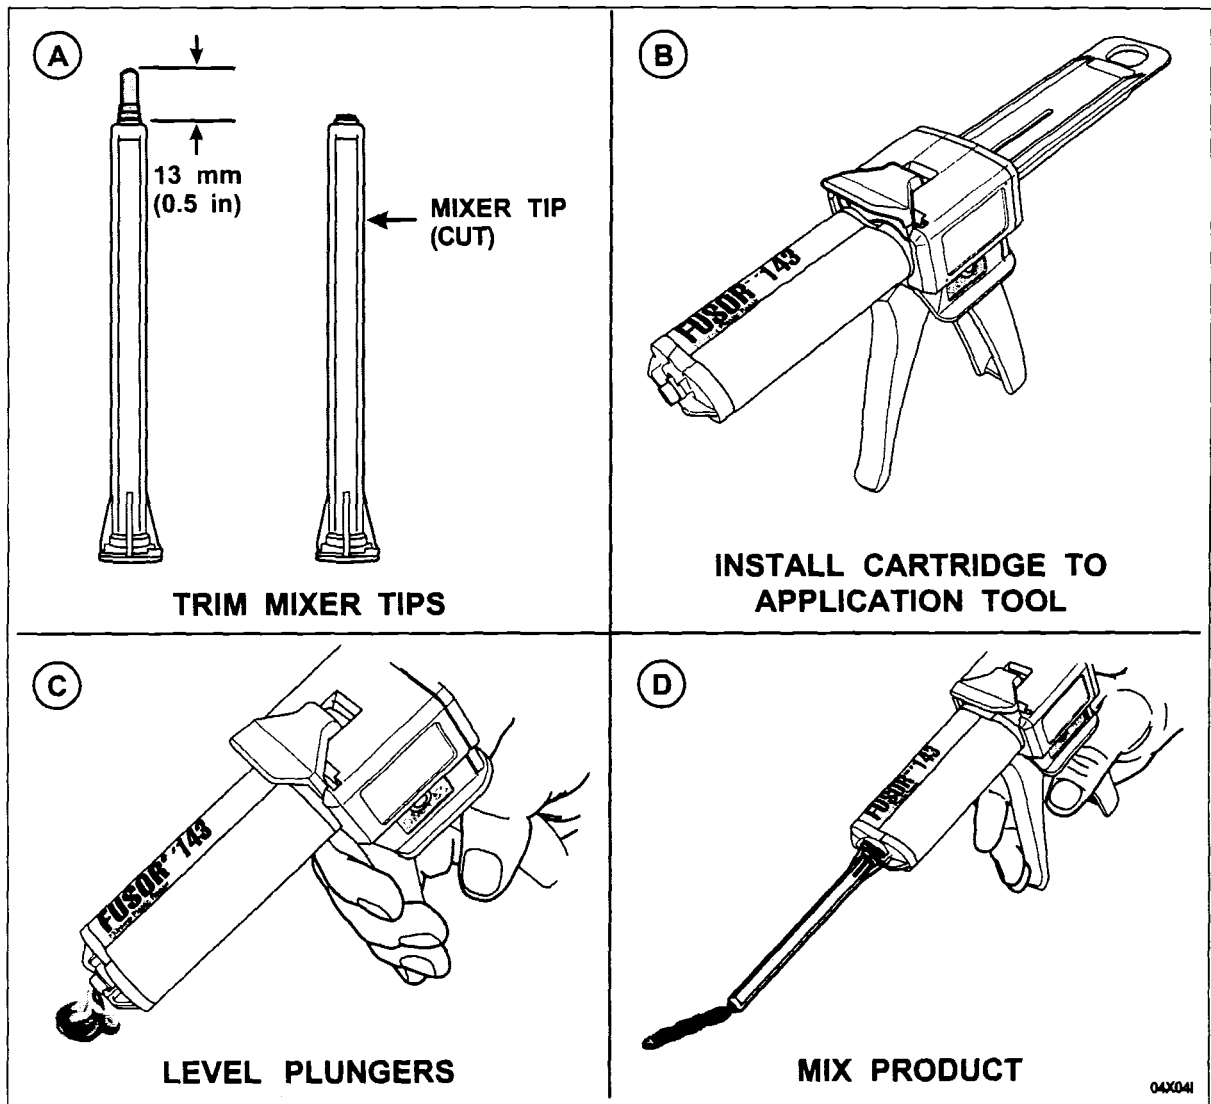
FIGURE 9

9. **CAUTION:** Failure to prepare the adhesive cartridge and mixer tip as described may cause insufficient mixing of the product. This may lead to insufficient bonding of the bracket(s) to the glass.

- A) Trim approximately 13 mm (0.5 in) off the top of both mixer tips, down to the last ring. See Figure 9.
- B) Install the Fusor® #143 adhesive cartridge into the application tool (No. 501-040).
- C) Dispense a small amount of adhesive from the cartridge onto a piece of scrap cardboard to level the plungers and to ensure an even flow of both components.
- D) Install one (1) mixer tip onto the cartridge and dispense a 75-mm (3-in) bead of the adhesive onto a piece of scrap cardboard (until the product is evenly mixed and the color is consistent).

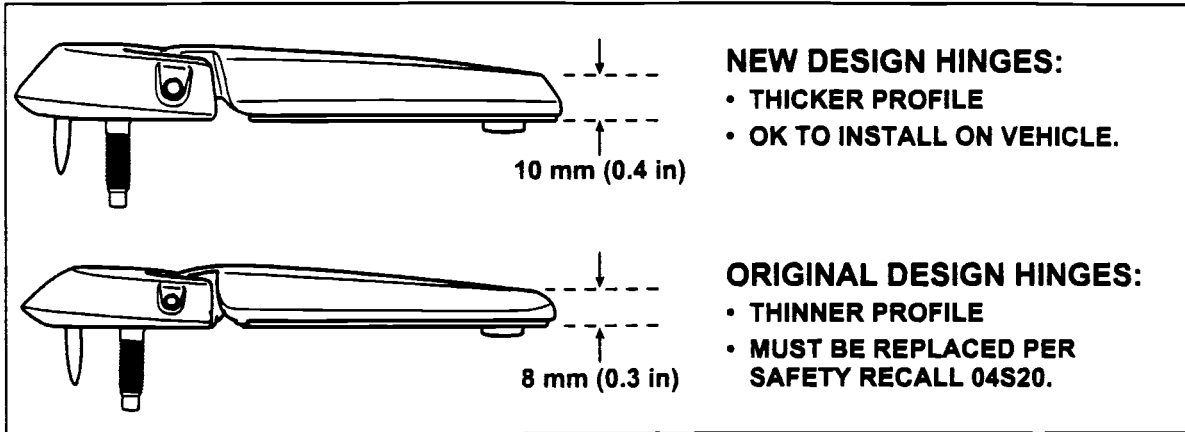
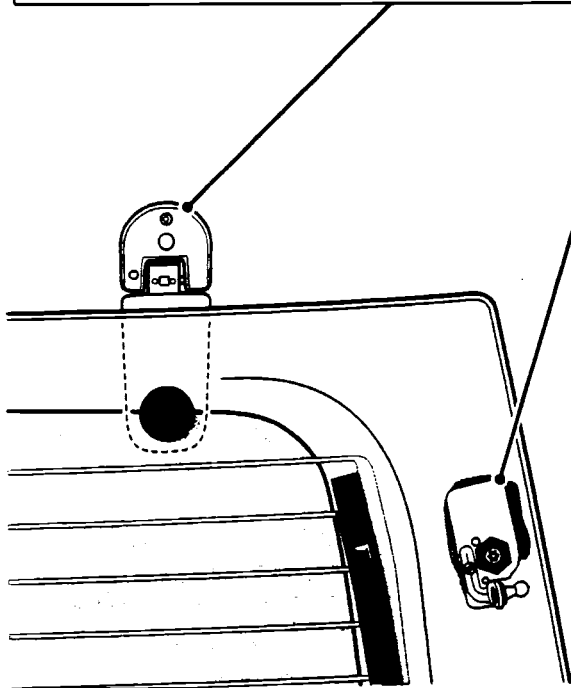
LARGE BRACKET:

- The new design hinges.
- Large strut brackets.
- Hard adhesive.

- INSPECT FOR SOFT ADHESIVE BY ATTEMPTING TO LEAVE IMPRESSIONS WITH FINGERNAIL.
- BRACKET MUST BE REPLACED PER SAFETY RECALL 04S20 IF ADHESIVE IS SOFT.
- BRACKETS OK IF ADHESIVE IS HARD.

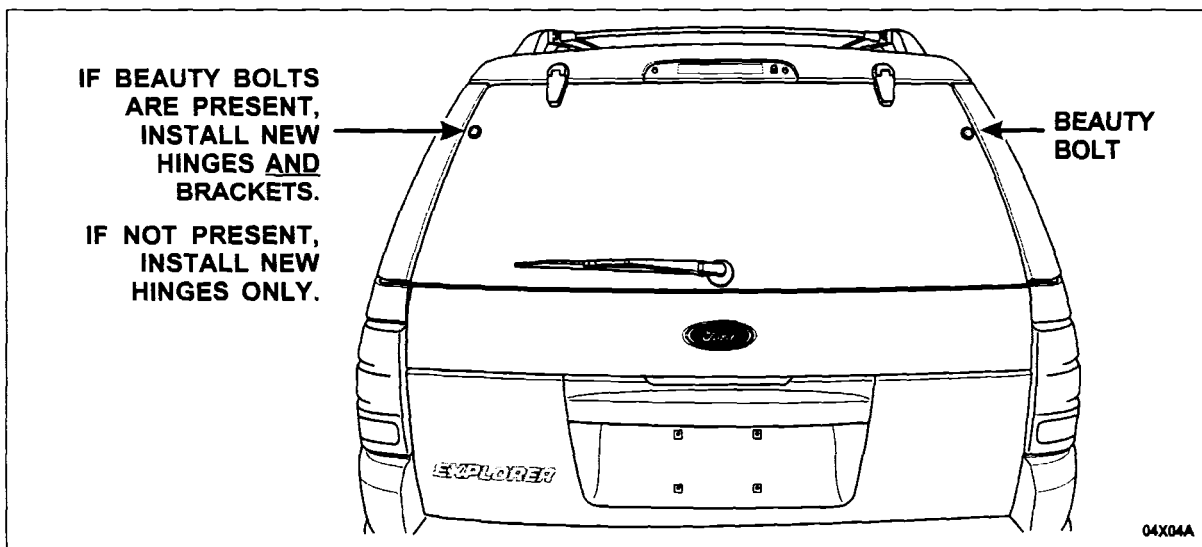
FIGURE 1

- Early 2002 models use ball stud brackets that are secured with beauty bolts, which pass through the glass (the head of the bolt is visible on the outside of the glass) and are bonded to the glass about 150 mm (6 inches) from the top of the glass. See Figure 1. If beauty bolts are present, both the liftgate ball stud brackets and hinges will be replaced. Perform BOTH the Liftgate Glass Hinge Replacement and the Ball Stud Bracket Replacement. Begin your repairs with LIFTGATE GLASS HINGE REPLACEMENT.
- Later built 2002 and 2003 model year vehicles use revised ball stud brackets which are not secured with beauty bolts. If beauty bolts are not present, only the hinges will be replaced. Perform only the LIFTGATE GLASS HINGE REPLACEMENT.

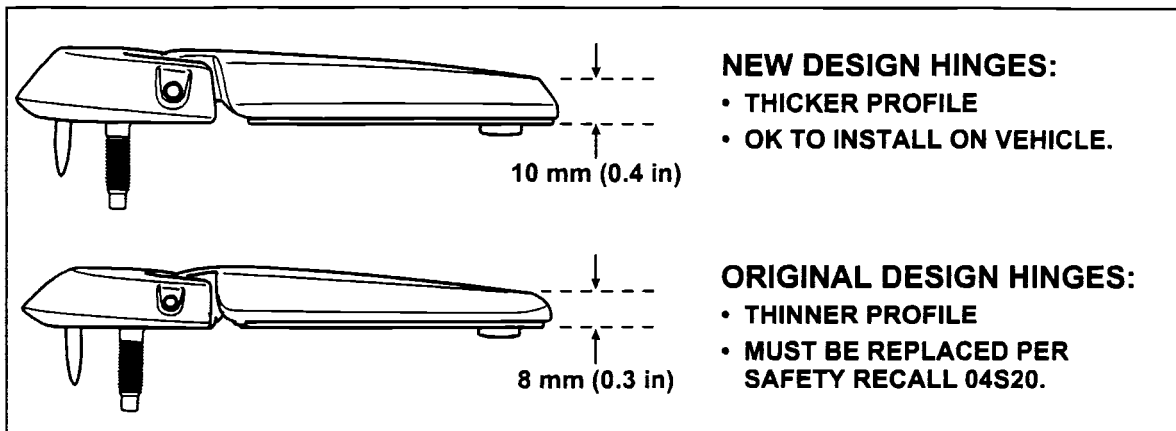
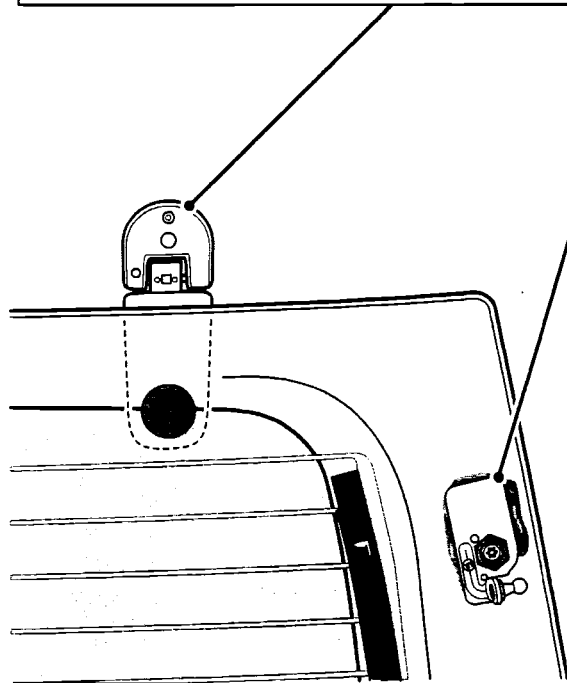
LARGE BRACKET:

- The new design hinges.
- Large strut brackets.
- Hard adhesive.

- INSPECT FOR SOFT ADHESIVE BY ATTEMPTING TO LEAVE IMPRESSIONS WITH FINGERNAIL.
- BRACKET MUST BE REPLACED PER SAFETY RECALL 04S20 IF ADHESIVE IS SOFT.
- BRACKETS OK IF ADHESIVE IS HARD.

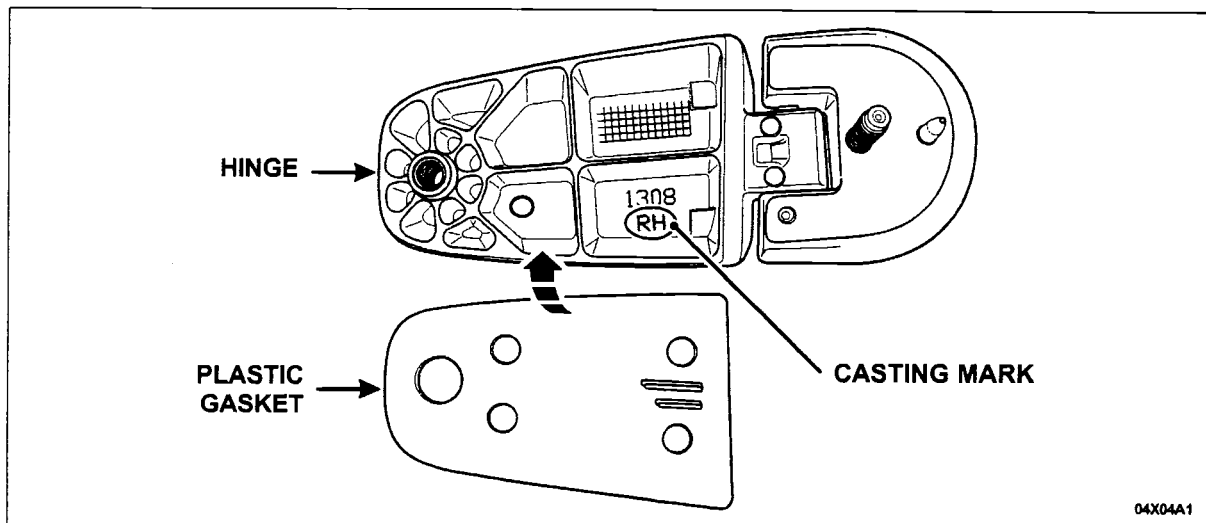
WARNING: THE *NEW* HINGES AND PLASTIC HINGE GASKETS ARE IDENTIFIED AS EITHER RIGHT-HAND OR LEFT-HAND (PASSENGER SIDE OR DRIVER SIDE). IF INSTALLED ON THE WRONG SIDE OF THE VEHICLE, THE GLASS MAY SHATTER. SEE FIGURE 1 FOR IDENTIFICATION DETAILS.

WARNING: THE *NEW* HINGES ARE IDENTIFIED AS EITHER RIGHT-HAND OR LEFT-HAND (PASSENGER SIDE OR DRIVER SIDE). IF INSTALLED ON THE WRONG SIDE OF THE VEHICLE, THE GLASS MAY SHATTER. SEE FIGURE 1 FOR IDENTIFICATION DETAILS.

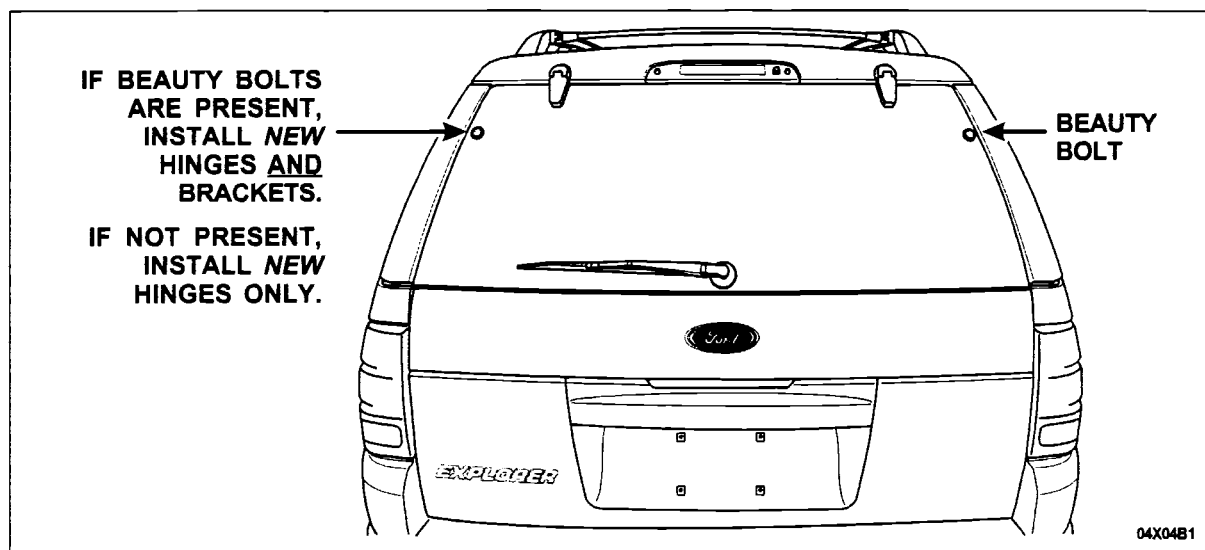
FIGURE 2

- Early 2002 models use ball stud brackets that are secured with beauty bolts, which pass through the glass (the head of the bolt is visible on the outside of the glass) and are bonded to the glass about 150 mm (6 inches) from the top of the glass. See Figure 2. If beauty bolts are present, both the liftgate ball stud brackets and hinges will be replaced. Perform **BOTH** the Liftgate Glass Hinge Replacement and the Ball Stud Bracket Replacement. Begin your repairs with **LIFTGATE GLASS HINGE REPLACEMENT**.
- Later built 2002 and 2003 model year vehicles use revised ball stud brackets which are not secured with beauty bolts. If beauty bolts are not present, only the hinges will be replaced. Perform only the **LIFTGATE GLASS HINGE REPLACEMENT**.

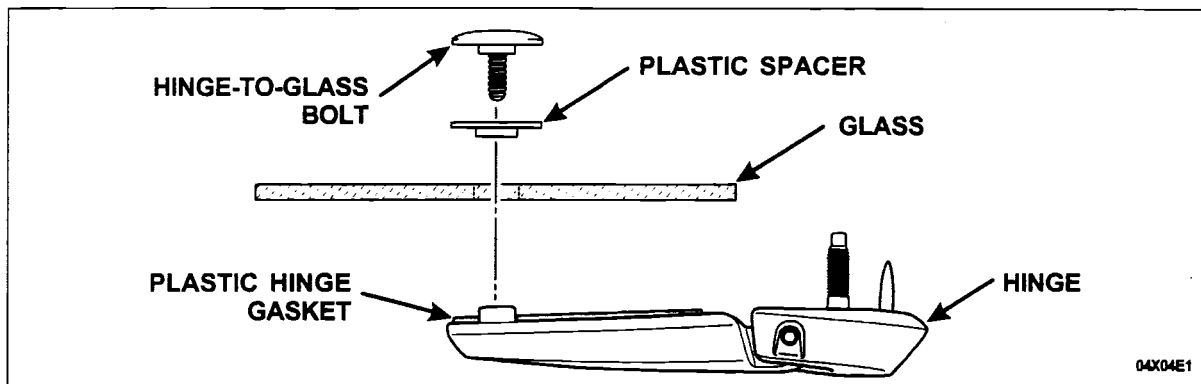
FIGURE 5

WARNING: THE PLASTIC SPACER LOCATED UNDER THE ORIGINAL HINGE-TO-GLASS BOLT MUST BE TRANSFERRED TO THE *NEW* BOLT. FAILURE TO INSTALL THIS SPACER WILL RESULT IN SHATTERING THE GLASS UPON BOLT INSTALLATION. SEE FIGURE 5.

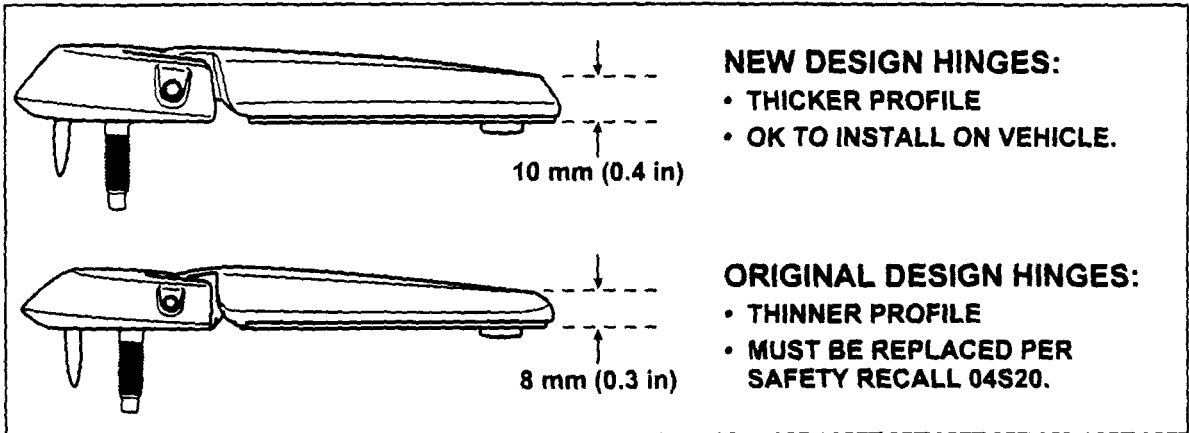
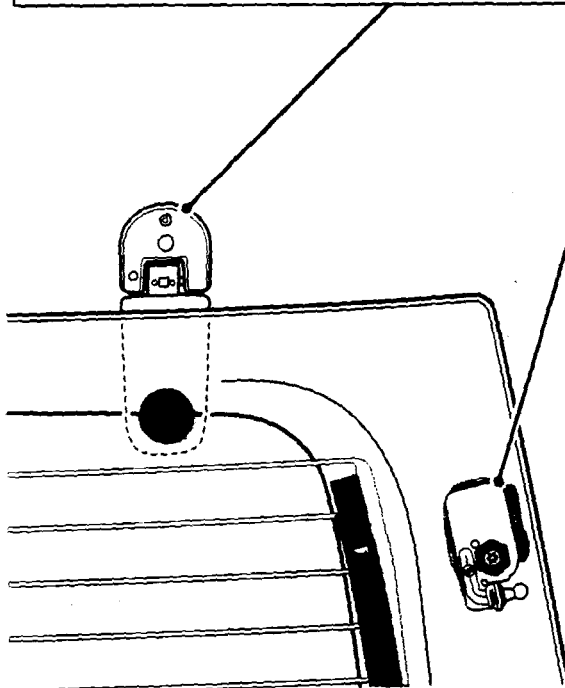
LARGE BRACKET:

- The new design hinges.
- Large strut brackets.
- Hard adhesive.

- INSPECT FOR SOFT ADHESIVE BY ATTEMPTING TO LEAVE IMPRESSIONS WITH FINGERNAIL.
- BRACKET MUST BE REPLACED PER SAFETY RECALL 04S20 IF ADHESIVE IS SOFT.
- BRACKETS OK IF ADHESIVE IS HARD.
