Recall Bulletin

Transport Canada Recall Number: 04-331

National Traffic and Motor Vehicle Safety Number (NHTSA): 04V-447

SAFETY DEFECT - Locking Pin Upgrade to Battery Tray

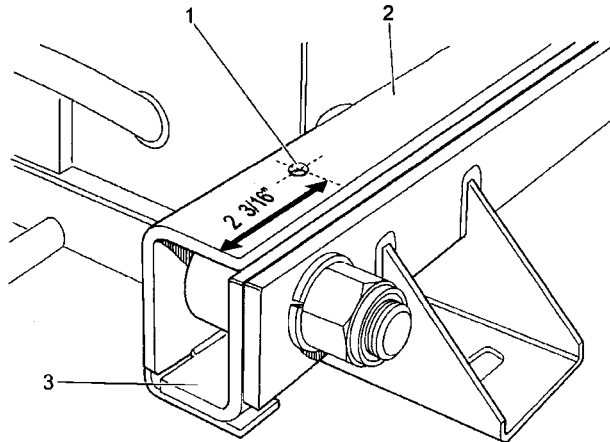
Figure 1-1 Quick Release Pin Hole

Orion Bus Industries Inc. has decided that a defect, which relates to motor vehicle safety act, exists in some of its transit buses. The battery tray could possibly slide out, while the vehicle is in motion, resulting in a potential vehicle collision.

1. Using a square key lock, open the battery compartment door, located on the rear curbside of the vehicle.
2. Move the isolator switch to the OFF position.
3. Drill 2 3/16" from the center edge of the battery tray arm (2), a 3/8" hole (1). Refer to **Figure 1-1**.

Ensure that the hole completely goes through the bottom plate (3). Refer to Figure 1-1.

We have determined that Orion Locking Pin Upgrade to Battery Tray Recall (Transport Canada Recall Number: 04-331 or National Traffic and Motor Vehicle Safety (NHTSA) Number: 04V-447) has an incorrect dimension. The correct dimension for drilling the locating hole is 2.19 in. from the end.
