Mazda North American Operations

SUBJECT: 2004 MAZDA3 Crash Zone Sensor Recall 2304J

2004 MAZDA3 CRASH ZONE SENSOR [RECALL 2304J]

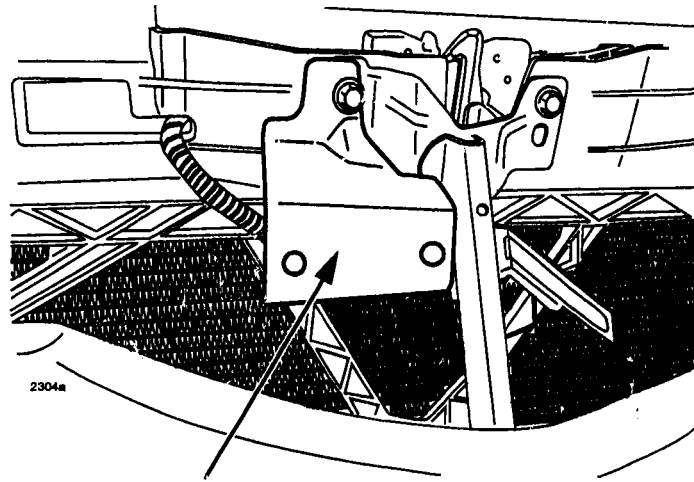
**REMOVE COVER
OF CRASH ZONE
SENSOR**

1. Open the hood.
2. Remove cover of crash zone sensor (CZS).

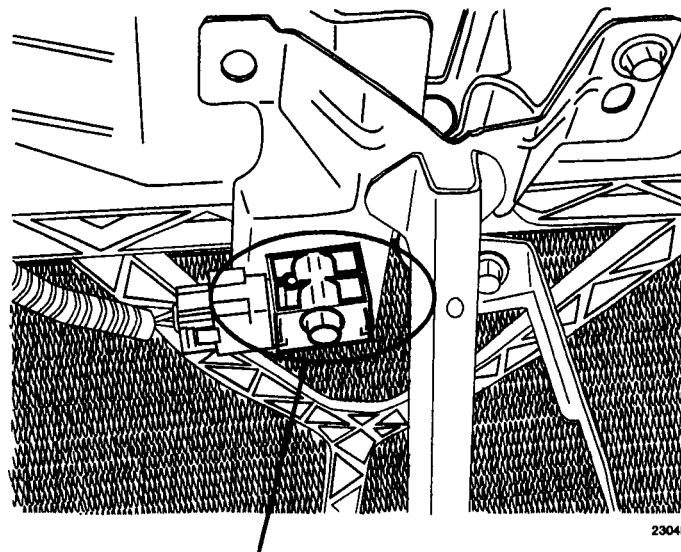
3. Inspect bolt for presence of white silicon at bolt head, end of bolt, and on top of the CZS surfaces.
 - If silicon is present, install cover, install recall sticker on hood, and return vehicle to the customer or inventory.
 - If silicon is not present, proceed to **REPAIR PROCEDURE**.

**INSPECT THE PRESENCE OF WHITE SILICON
AT BOLT HEAD, END OF BOLT, ON TOP OF,
AND SURROUNDING SURFACES
OF CRASH ZONE SENSOR**
