SUBJECT: Campaign #91 S-Series Wire Cover/Accelerator Pedal Interference

**INSTRUCTIONS TO PERFORM CAMPAIGN #91**  
**Inspect/Reposition Driver Side Dash Wiring Shield**  
**on Vectra and Horizon Motorhomes built on Freightliner**  
**chassis with Cummins 400 diesel engine**

RECALL 91

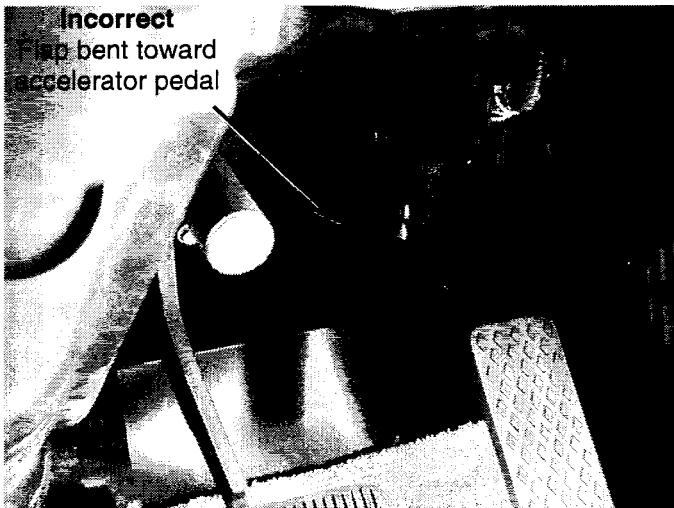
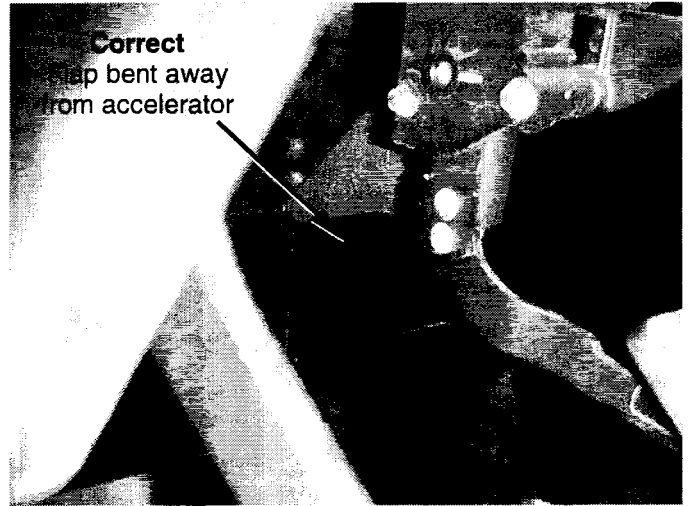
**Wiring Shield beneath driver side dash on S-series units (Vectra/Horizon)**

See the following photos which show improper and proper orientation of the access flap on the wiring shield.

The basic procedure involves inspecting the dash wiring shield beneath the driver side of the dash and if necessary, bending the access flap forward by hand (away from accelerator linkage) to increase clearance for proper accelerator actuation.

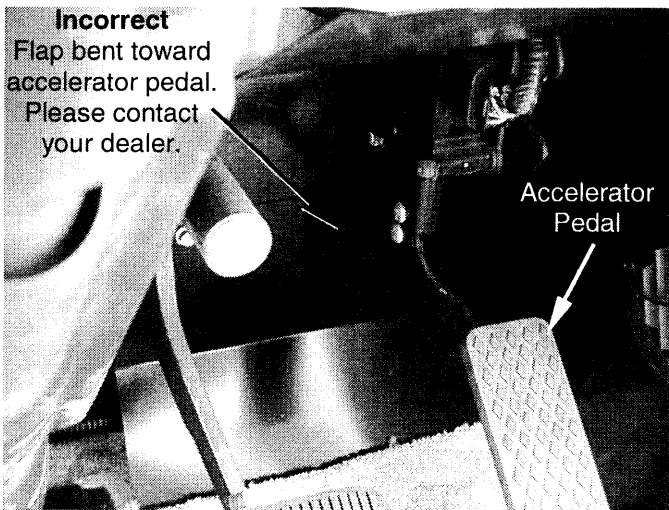
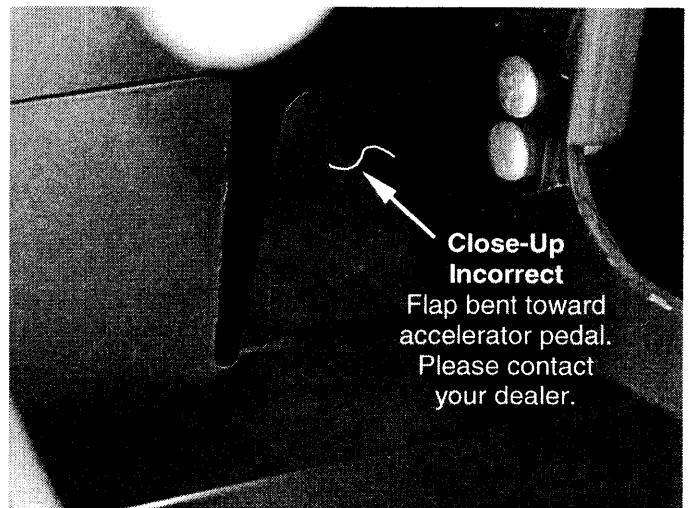
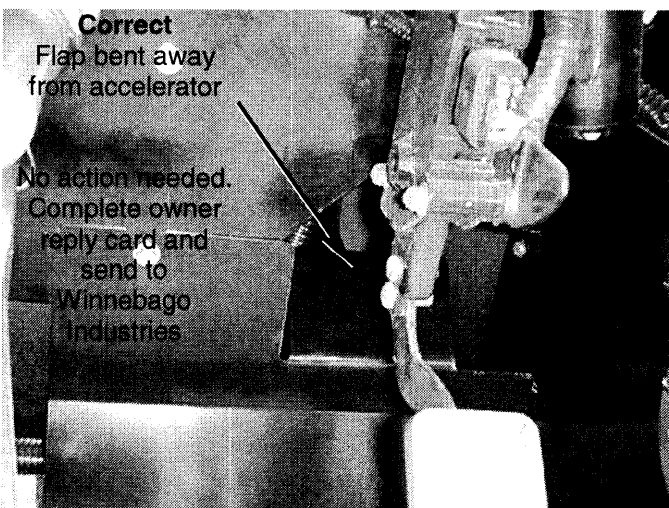
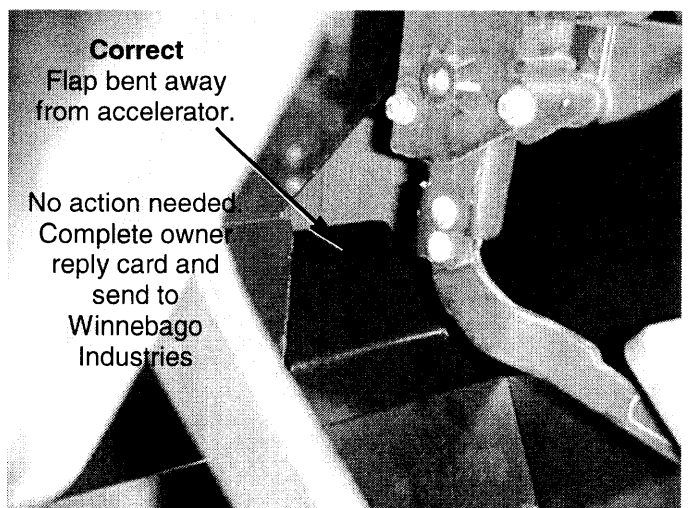
**Wiring shield beneath driver side of dash on Winnebago Vectra or Itasca Horizon)**

The basic procedure involves inspecting the dash wiring shield beneath the driver side of the dash. See the following photos which show improper and proper orientation of the access flap on the wiring shield. Please inspect the wire cover, then depending on condition, contact your dealer or complete the Owner Reply Card and send to Winnebago Industries as described in the photos below.
