04V-472

**G-04518-R2**  
**April 2005**

**SUBJECT: SAFETY RECALL (U.S., EXPORT)**  
**TURN SIGNAL SWITCH assemblies on certain 3300,**  
**4200, 4300, 4400, and CE School Bus models built**  
**5/24/2004 thru 8/17/2004**

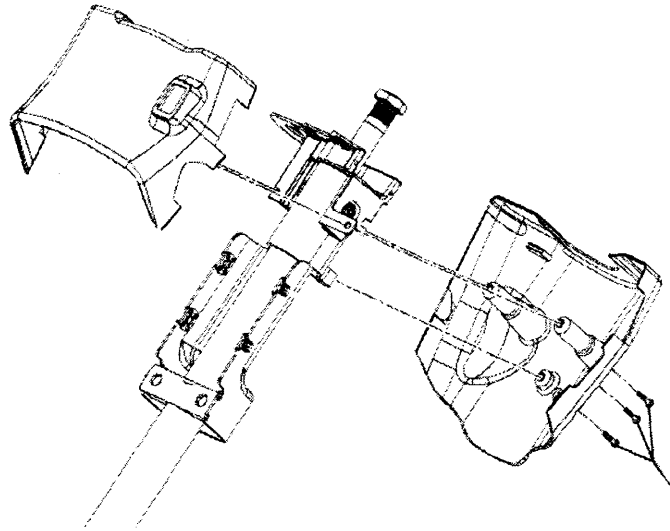
**Figure 1**

1. Remove the three (3) screws that fasten the lower steering column trim to the steering column.

7. Install new switch assembly and connect electrical connector. See **Figure 4**.
  - a. If the vehicle has a Blue Bird body, use **2589451C91**.
  - b. For all other vehicles and bus bodies, use **3587009C91**.
8. Perform functional test on switch to verify all turn signals and hazard lamps function.
9. Re-install upper and lower steering column trim panels. See **Figure 1**.

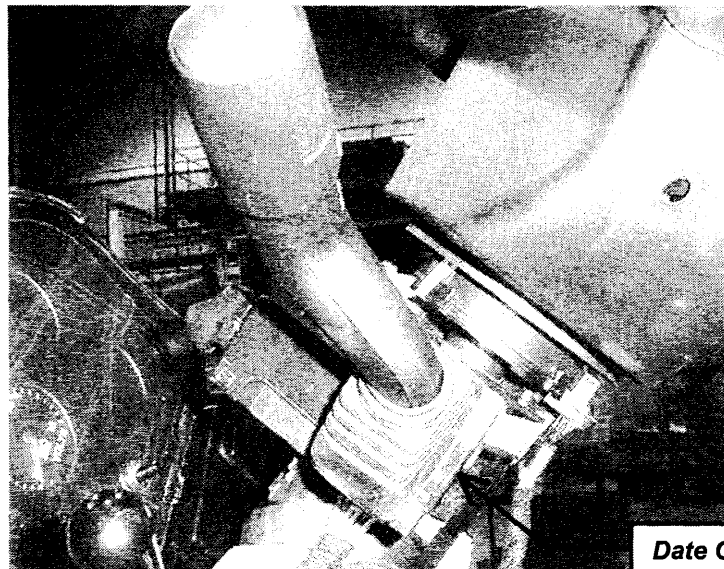
**Figure 2**

2. Inspect the underside of the turn signal stalk assembly for the build date code.

***Date Code in  
This Area***

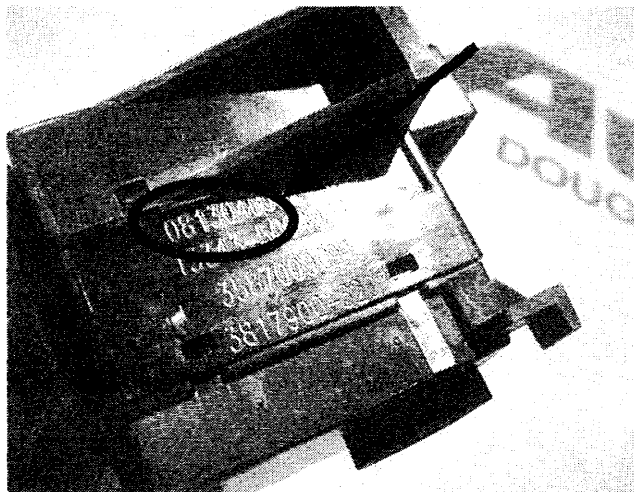
**Figure 3**

**NOTE:** The example in Figure 3, 081304, corresponds to a build date of August 13<sup>th</sup> of 2004.

3. Replacement of the turn signal switch is required if the switch build date codes are between **051504** (May 15, 2004) thru **062804** (June 28, 2004). If the build date is within this range, skip to step 5.
4. If the date code on the switch assembly is **NOT** in the range listed in step 3, **NO FURTHER ACTION IS NECESSARY**, re-install lower column trim panel and fasteners.

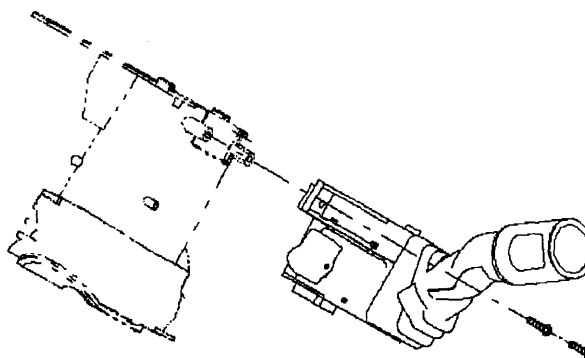
**Figure 4**

5. Remove the upper column trim panel.
6. Disconnect electrical connector and remove switch assembly.
