04V-472

# VEHICLE RECALL

G-04518-R1  
December 2004

**SUBJECT:** SAFETY RECALL (U.S., EXPORT)  
TURN SIGNAL SWITCH assemblies on certain 3300,  
4200, 4300, 4400, and CE School Bus models built  
5/24/2004 thru 8/17/2004

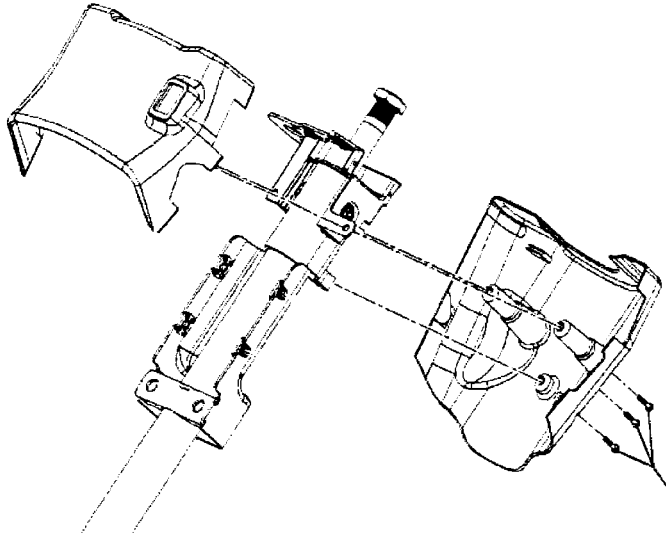
**Figure 1**

1. Remove the three (3) screws that fasten the lower steering column trim to the steering column.

7. Install new switch assembly and connect electrical connector. See **Figure 4**.
8. Perform functional test on switch to verify all turn signals and hazard lamps function.
9. Re-install upper and lower steering column trim panels. See **Figure 1**.

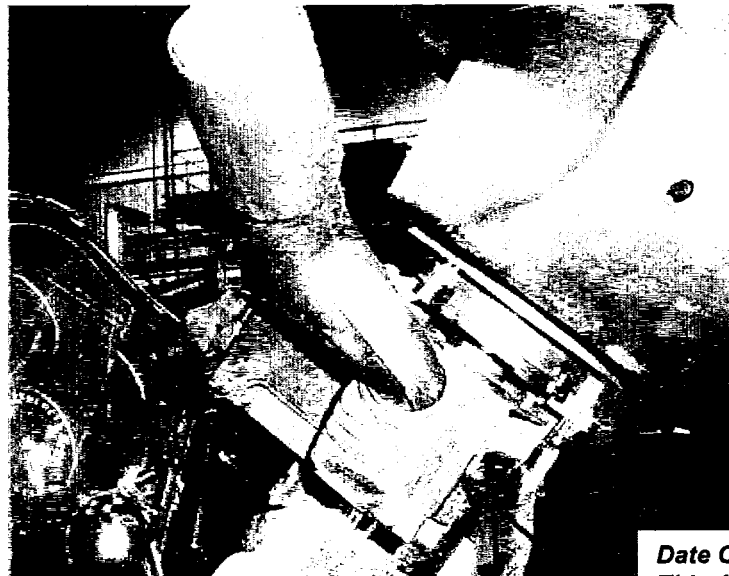
**Figure 2**

2. Inspect the underside of the turn signal stalk assembly for the build date code.

***Date Code in  
This Area***

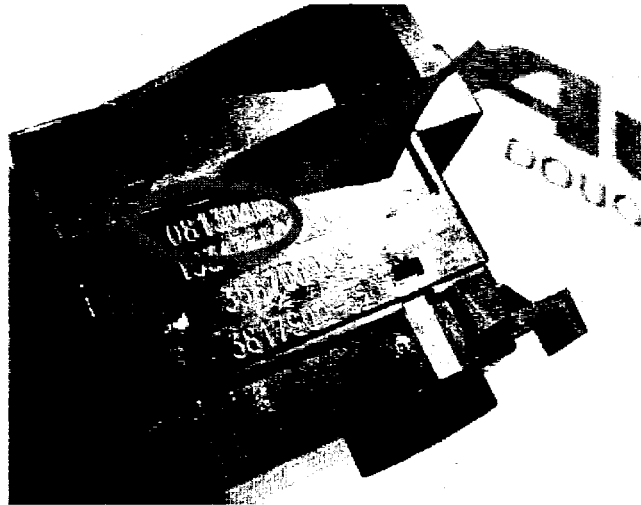
Figure 3

**NOTE:** The example in Figure 3, 081304, corresponds to a build date of August 13<sup>th</sup> of 2004.

3. Replacement of the turn signal switch is required if the switch build date codes are between **051504** (May 15, 2004) thru **062804** (June 28, 2004). If the build date is within this range, skip to step 5.
4. If the date code on the switch assembly is **NOT** in the range listed in step 3, **NO FURTHER ACTION IS NECESSARY**, re-install lower column trim panel and fasteners.

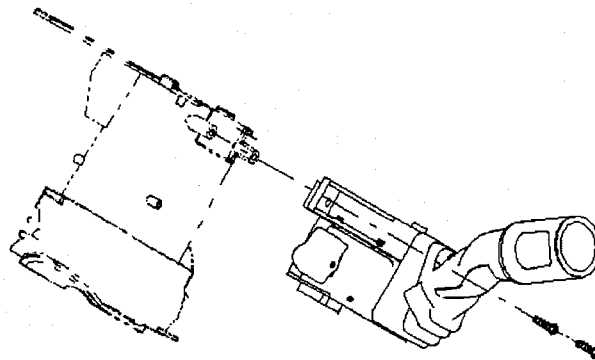
Figure 4

5. Remove the upper column trim panel.
6. Disconnect electrical connector and remove switch assembly.
