PRODUCT CAMPAIGN BULLETIN

APPLICABILITY: 2004 MY Turbo Subaru Forester,
STi & BAJA
SUBJECT: Engine Oil Control Valve Cover Bolts

NUMBER: WWU-05
DATE: 10/2004

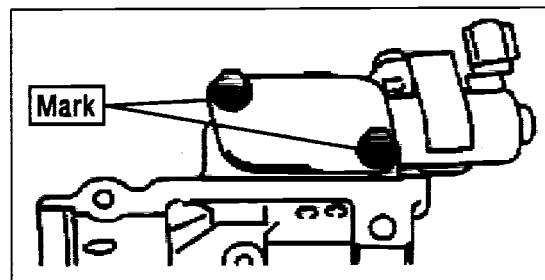
Fig.8: Oil-flow Control Valve Cover

Note: The bolts may have loosened over time. Therefore, it will be necessary to determine if the bolts are loose prior to performing the final tightening procedure. It is important NOT to over-tighten the bolts.

While following the procedures for **Steps A (Right Hand Side) and B (Left Hand Side)** on page 5, verify that the surface of the bolt flange is in contact with the cover.

- **If it is not**, lightly tighten the bolt using the Special Tool -- DO NOT tighten completely at this point. Then, put a paint mark on the bolt flange to mark the original position (See Fig. 8).
- **If it is**, put a paint mark on the bolt flange to mark the original position (See Fig. 8).

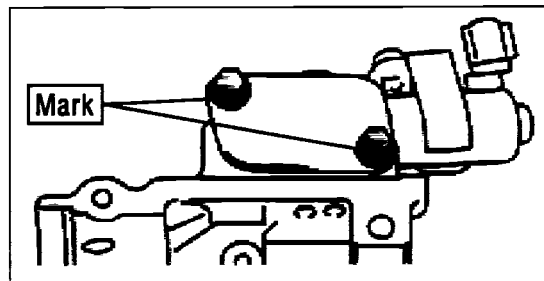
Fig.8: Oil-flow Control Valve Cover

Note: The bolts may have loosened over time. Therefore, it will be necessary to determine if the bolts are loose prior to performing the final tightening procedure. It is important NOT to over-tighten the bolts.

While following the procedures for **Steps A (Right Hand Side) and B (Left Hand Side)** on page 5, verify that the surface of the bolt flange is in contact with the cover.

- **If it is not**, lightly tighten the bolt using the Special Tool -- DO NOT tighten completely at this point. Then, put a paint mark on the bolt flange to mark the original position (See Fig. 8).
- **If it is**, put a paint mark on the bolt flange to mark the original position (See Fig. 8).
