Recall Information Bulletin

No: R3123510 Issued: 10/21/2004

Re: Front Hub Bearing FH-FK

Safety Recall R3123510 - Front Hub Bearing FH-FK

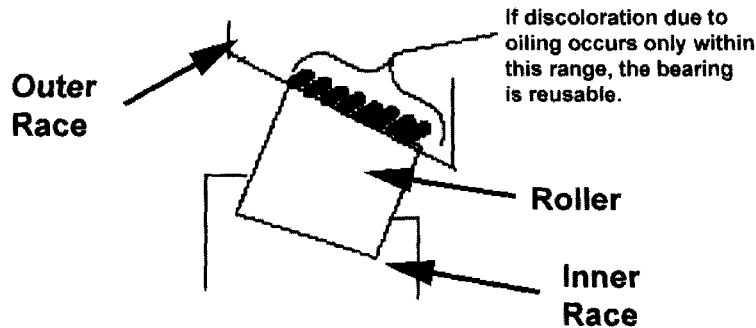
ILLUSTRATION 2

A) The bearing race and roller are discolored due to oiling. The contact point between the bearing race and roller may turn blue or purple in color, due to discoloration by oiling. If the bearing has no abnormality except discoloration due to oiling, reuse it (ILLUSTRATION 2).
