**Triumph Motorcycles Notice : New Safety Recall, Rear Suspension Units****Notice Information**

## **REPLACEMENT OF REAR SUSPENSION UNITS**

## Recall Action Notice Service Bulletin 353

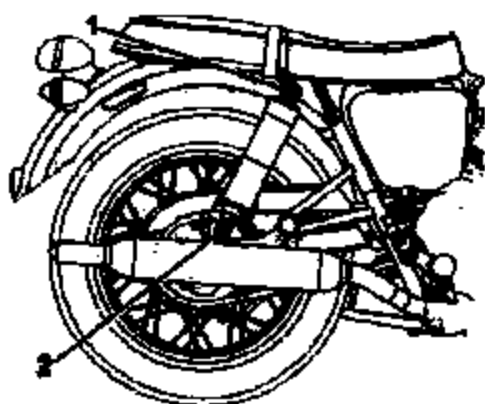
1. Upper mounting point

2. Lower mounting point

2. Slacken and remove the left hand upper and lower suspension unit mounting bolts and washers then remove the suspension unit.

3. Locate the new suspension unit on its mountings adjusting the swinging arm position if necessary to locate the upper and lower mountings.
4. Apply Threadbond 1205 (or equivalent) to the threads of the rear suspension unit fixings.
5. Install the mounting bolts and washers then tighten the bolts to 25 Nm.
6. Repeat operations 2 to 5 for the right hand rear suspension unit.

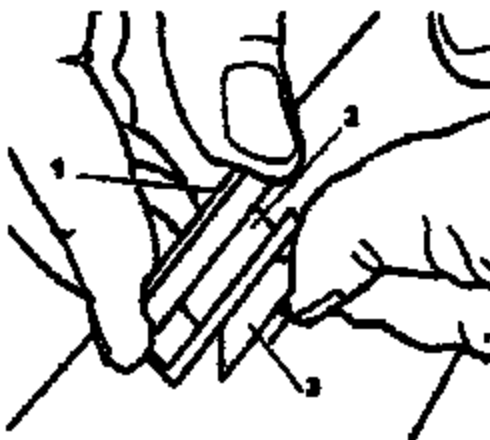
1. Collar

2. Rubber mounting

3. Rubber washer

- Ensure the rubber mountings, collars and rubber washers are correctly fitted to the silencer brackets.

- Apply 4cc of clear silicone sealer to each header pipe at the join with the silencers. Spread the sealer evenly all round the joints.
- Fit the mounting clamps and if removed, fit the clamp shield, then install the silencers.
- Install the passenger footrests, ensuring the locking pins are correctly seated in their holes. Fit the washers and nuts to the footrests and tighten to 22 Nm.
- Position the silencer clamps correctly and tighten the bolts to 28 Nm.

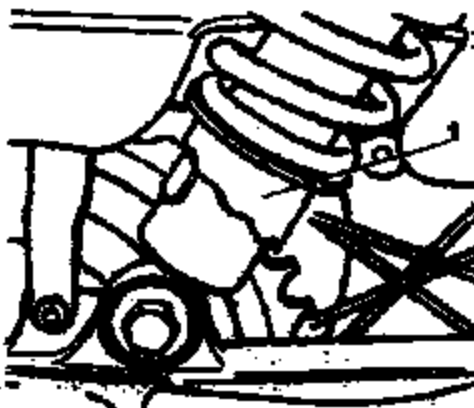
1. Rear suspension preload adjuster

Ensure both rear suspension unit preload adjusters are set to the same setting. If the spring preload is not equally adjusted, the handling of the motorcycle will be adversely affected which could lead to loss of control, resulting in an accident.

- 7 Lower the motorcycle to the ground and place on its side stand.
- 8 Ensure that both rear suspension unit preload adjusters are set to the same setting.
