Subject: 2004 M45/Q45 Brake Lamp Switch Voluntary Recall Campaign

ITB04-058

## VOLUNTARY RECALL CAMPAIGN BRAKE LAMP SWITCH

**CAMPAIGN I.D # / NHTSA #:** R0407 / 04V-497**APPLIED VEHICLES:** 2004 M45 (Y34)  
2004 Q45 (F50)**APPLIED VINS:** See Applied VIN List (next page)**NOTE:** Use Service Comm to confirm campaign eligibility.

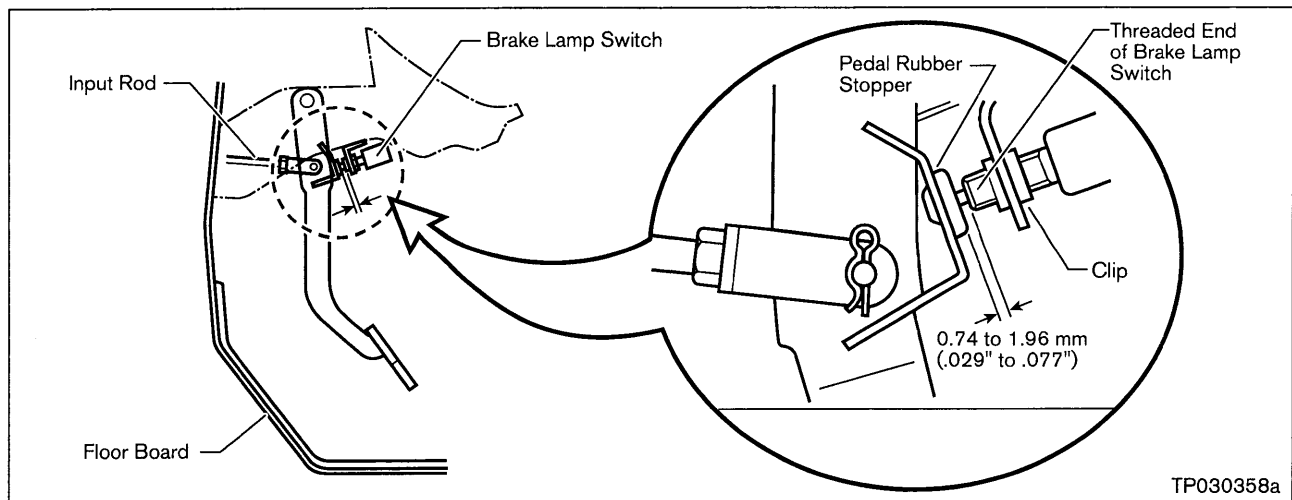
Figure 7

**Clearance specification = 0.74 – 1.96 mm (.029 – .077 inches)**

5. Use a "Feeler Gauge" (or other suitable tool) to check the clearance between the Pedal Rubber Stopper and the threaded end of the Brake Lamp Switch (see Figure 7). Make sure it is within the clearance specification shown below.

If the clearance does **NOT** fall within this specification, adjust the Switch as follows:

- a. Turn the Switch counter-clockwise 45 degrees to release it from the support bracket.
  - b. Move the Switch towards the pedal or away from the pedal until the clearance is within specification.
  - c. Turn the Switch clockwise 45 degrees so that it is fully locked into position.
6. Confirm the brake lamps operate properly.

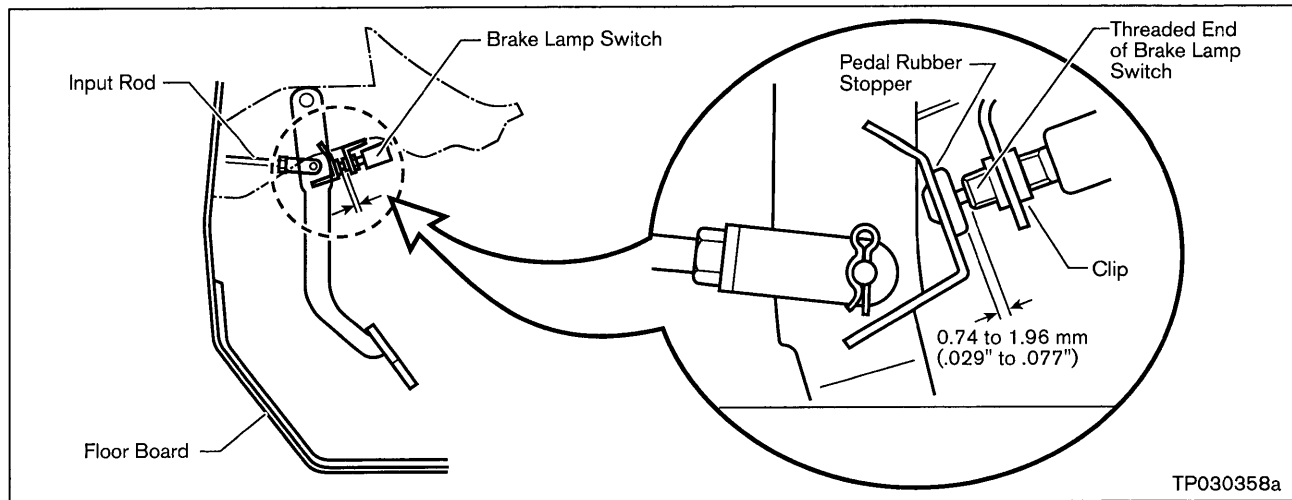
Figure 16

**Clearance specification = 0.74 – 1.96 mm (.029 – .077 inches)**

5. Use a "Feeler Gauge" (or other suitable tool) to check the clearance between the Pedal Rubber Stopper and the threaded end of the Brake Lamp Switch (see Figure 16). Make sure it is within the clearance specification shown below.

If the clearance does **NOT** fall within this specification, adjust the Switch as follows:

- a. Turn the Switch counter-clockwise 45 degrees to release it from the support bracket.
  - b. Move the Switch towards the pedal or away from the pedal until the clearance is within specification.
  - c. Turn the Switch clockwise 45 degrees so that it is fully locked into position.
6. Confirm the brake lamps operate properly.
