**RE: RECALL CAMPAIGN 142-USA: HEADLIGHT SWITCH - INSPECT / REPLACE**

<h1 style="margin: 0;">VOLVO</h1> <h2 style="margin: 0;">Service Manager Bulletin</h2>				TITLE:		GROUP: 36	NO: 142B		
				<b>Recall Campaign 142: Headlight Switch - Inspect / Replace</b>		ISSUING DEPARTMENT: <b>Warranty</b>			
REFERENCE BULLETINS: <b>PB 36-142B TNN 36-142B</b>		CARMARKET: <b>United States</b>							
		SERVICE PERSONNEL: <table border="1" style="width: 100%; border-collapse: collapse;"> <tr> <td style="width: 25%; text-align: center;">SERVICE MANAGER</td> <td style="width: 25%; text-align: center;">SERVICE WRITER</td> <td style="width: 25%; text-align: center;">WARRANTY ADMINISTRATOR</td> </tr> <tr> <td style="height: 20px;"> </td> <td> </td> <td> </td> </tr> </table>		SERVICE MANAGER	SERVICE WRITER	WARRANTY ADMINISTRATOR			
SERVICE MANAGER	SERVICE WRITER			WARRANTY ADMINISTRATOR					
Service Personnel: read and initial.		YEAR    MONTH    DAY							
		<b>2005    01    14</b>							
Service Personnel: read and initial.		<b>Page 1 of 3</b>

NO: 36-142B  
DATE: 01/14/05  
MODEL: S70, C70, V70 and V70XC  
M. YEAR: 1998 – 2000  
CHASSIS: 872-0002678-0020535  
873-0519898-0609561  
874-0519898-0609561

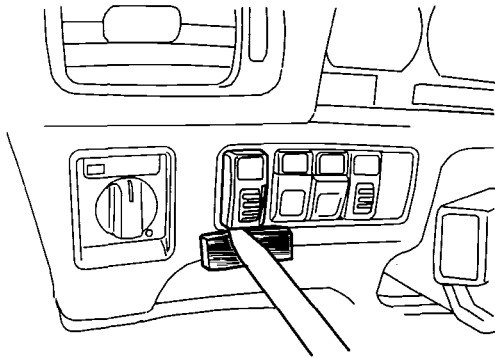
A3602582

**Remove the switch**

Remove the switch closest to the light switch.

Carefully insert a plastic weatherstrip tool between the panel and the lower edge of the toggle switch. Carefully pry outwards until it is possible to grip the connector socket with your fingers. Pull the connector socket out.

**Note!** Use shims so that the surrounding panel is not damaged.

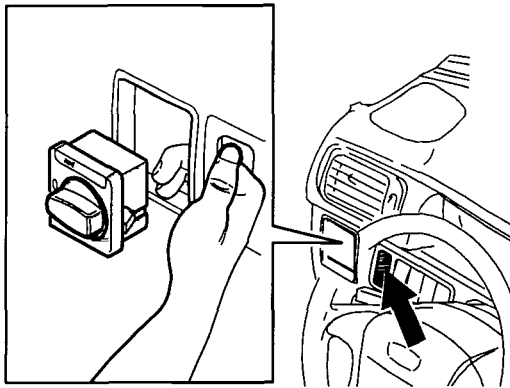
A3602525

**Remove the light switch**

Position a finger behind the light switch and push it out.

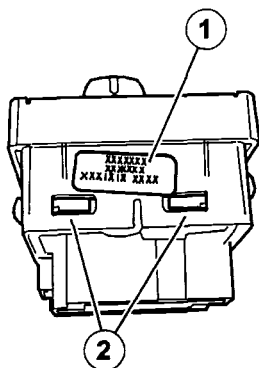
A3603739

### Check the light switch

Read the number (1) on the top of the light switch

8622022  
8622023  
8622024  
8622027  
8622028  
8622029  
8601772  
8601773  
8601774  
8601777  
8601778  
8601779

If the number is included in the above list, check that the four mounting lugs (2) (two on the top and two on the bottom), which hold the light switch together, were not damaged during removal.

If the number is included in the above list and the mounting lugs are intact then the light switch and the switch must be reinstalled.

If the number is not included in the above list, or if one or more of the mounting lugs has cracked during removal, then the light switch must be replaced.

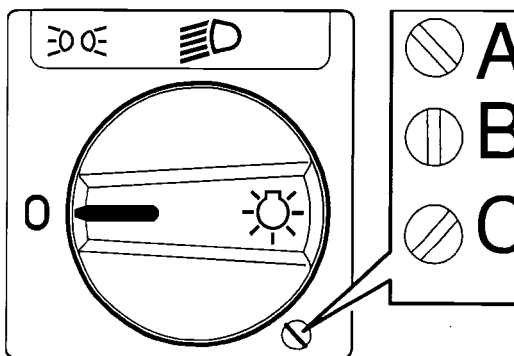
### Market adaptation of the light switch

When replacing the light switch, the new light switch must be adapted for the market. This is done using the adjusting screw down in the right-hand corner.

**Note!** The light switch for Canada cannot be reset.

Press and turn the selector on the light switch to the required position.

**Position A:** Dipped beam off when the ignition is on and the light switch is in position 0.

**Position B:** Dipped beam on when the ignition is on and the light switch is in position 0.

**Note!** The light switch must be adjusted in accordance with the market code for the vehicle. See the table in step 5.
