**G-04520**  
**November 2004**

**SUBJECT: SAFETY RECALL (U.S., EXPORT)**  
**MOUNTING BOLTS on IROS equipped 3200, 4200,**  
**4300, and 4400 models built 8/23/2004 thru 10/1/2004**

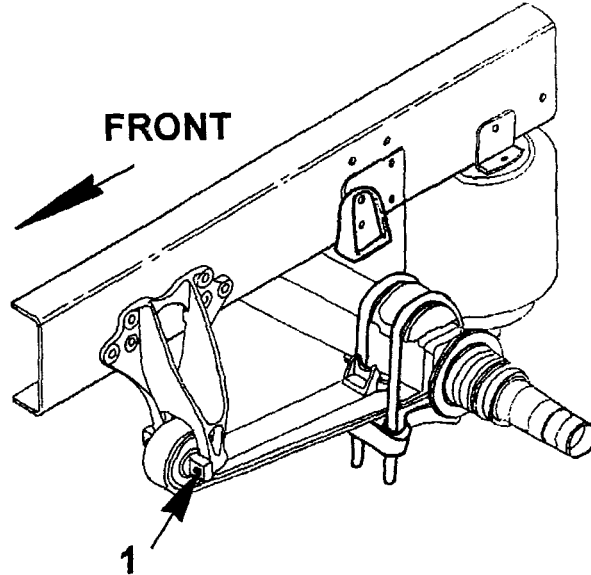
Figure 1

Four rear suspension fasteners may not be tightened sufficiently. This hardware connects the main support members of the rear suspension to the hanger brackets. This connection could fail by the nuts working their way loose or off, or the bolts could break from fatigue. A failure of these fasteners could result in separation of the main support from the hanger bracket possibly resulting in a sudden loss of control of the vehicle. This could cause a **vehicle crash without warning**, possibly resulting in **property damage, personal injury, or death**.

**NOTE:** The bolts go through the bushing bar pin in the direction of the arrow with the bolt head against the bar pin (**FORWARD**) and the nut against the hanger (**REAR**). There are two bolts and two nuts required per side.

1. Remove one bolt and nut at a time, then install a new bolt and nut.

2. Tighten the new bolt almost to full torque [full torque is **370-460 LbF-Ft (500-625 Nm)**] so that the clamp load will hold the bushing pin aligned while the other bolt is replaced.
3. Repeat step 2 until all four bolts and nuts have been replaced.
4. Finally, fully tighten all four (4) bolts to **370-460 LbF-Ft (500-625 Nm)**.

**NOTE: DO NOT REUSE ANY OF THE ORIGINAL BOLTS OR NUTS**
