# VEHICLE RECALL

## SC290

**Subject:** Step Support Pedestal Weld Quality — CV Model Chassis

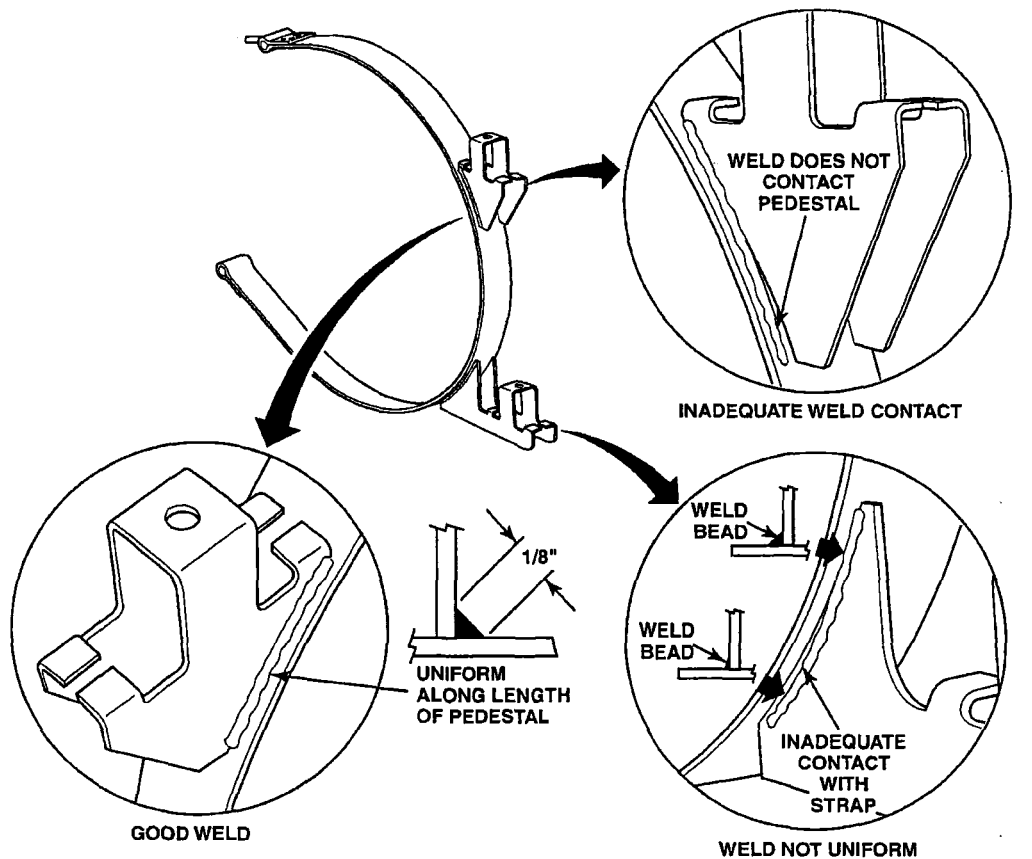
Figure 2 — Step Pedestal Welds

It has been determined that on certain CV model chassis, the step pedestals may not have been welded properly to the fuel tank straps. As a result, the step pedestal may separate from the fuel tank strap and cause the vehicle operator or passenger to fall from the vehicle when entering or exiting the cab. Approximately 920 CV model chassis manufactured between July 19, 2004 and August 25, 2004 are involved in this campaign. A list of affected vehicles has been sent to all applicable dealers.

The bead of weld attaching the pedestal to the strap must have equal coverage on both the strap and pedestal. Check both step pedestals (two pedestals per strap). The weld bead should be approximately 1/8" (3.1 mm) wide with equal contact between the pedestal and strap along the entire length of the pedestal. If the weld is less than 1/8" (3.1 mm), or the weld does not contact both the strap and pedestal, the strap must be replaced with new straps (part Nos. 8MB429 for painted finish, or 8MB430 for stainless steel polished finish). Refer to the following figure for illustrations of adequate and inadequate welds.

Remove and replace one strap at a time. When removing the strap, it will be necessary to support the fuel tank with a floor jack and wooden block. Cutting a wooden block to the contour of the fuel tank as shown in the following illustration will minimize the risk of the fuel tank falling from the jack.

When installing the new strap, reuse the existing rubber insulator between the tank and strap. If, however, the insulator is damaged, replace with part No. 798AM100F. Use a new T-bolt nut (part No. 190AM4) and tighten to the following specifications:

- **Steel Tank** — 40 lb-ft (54 N•m)
- **Aluminum Tank** — 35 lb-ft (48 N•m)
