Volume: XII
Number: TC05-004
Date: 02/24/2005
X Action
X Retain
Information

SPECIAL SERVICE CAMPAIGN (SSC) - 50D

(2000 THROUGH 2001 MODEL YEAR CELICA DAYTIME RUNNING LIGHT (DRL))

2000 THROUGH 2001 MODEL YEAR CELICA DAYTIME RUNNING LIGHTS (DRL)

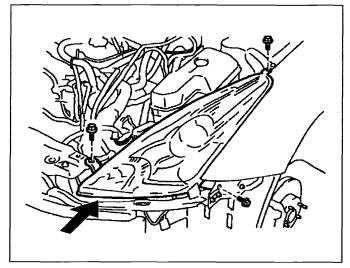
(a) Inspect the left headlight for any damage. If the bracket indicated in the illustration is broken, install a replacement bracket before reinstalling the headlight in the vehicle.

Refer to the Electronic Parts Catalog (EPC) for the headlight bracket part number and ordering information.
