04V-569

VEHICLE RECALL

INTERIM ACTION G-04521

**SUBJECT: INTERIM ACTION SAFETY RECALL (U.S., EXPORT)
CAB MOUNTS on certain 4000, 7000, and 8000
Series Models built 1/16/2004 thru 11/1/2004**

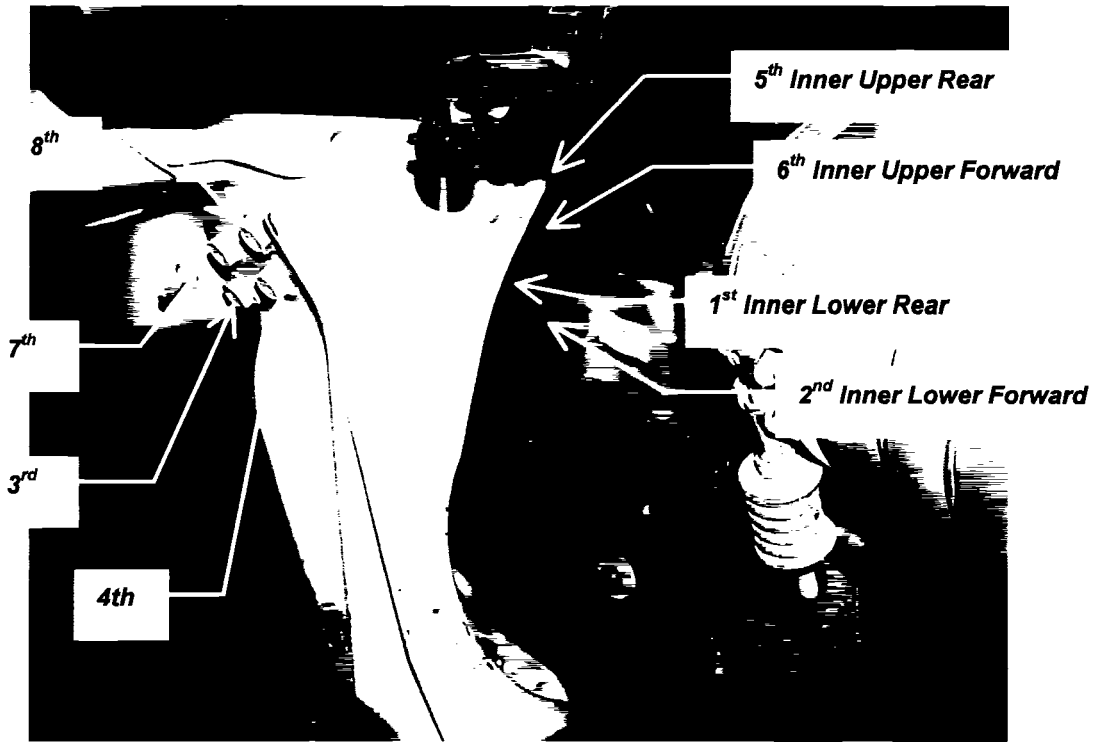
Figure 1 – Bolt Torque Pattern

<i>Bolt Torque Pattern per Side</i>	<i>Cab Mount Bolt Location</i>
1 st	Lower, Inner, Rear
2 nd	Lower, Inner, Forward
3 rd	Lower, Outer, Rear
4 th	Lower Outer, Forward
5 th	Upper, Inner Rear
6 th	Upper, Inner, Forward
7 th	Upper, Outer, Rear
8 th	Upper, Outer, Forward

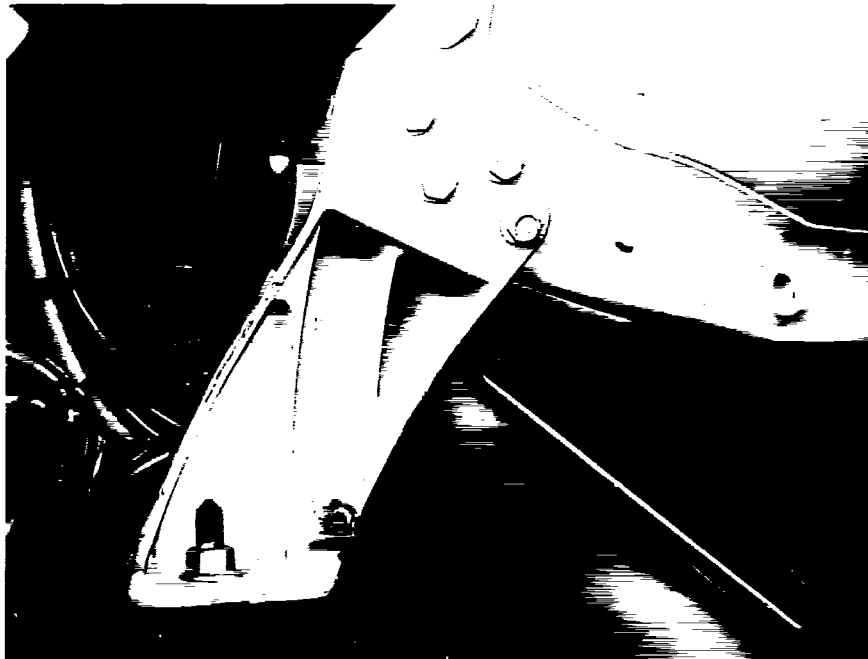
**Figure 3 – Access Inner Bolts from Under and Behind Mounts
(Driver's Side Shown)**
