Recall Information Bulletin
No: R3125410 **Issued:** 1/3/2005
Re: Fuel Injection Pipe Clamps
Group: 13 **Models:** FE, FH

Safety Recall R3125410 - Fuel Injection Pipe Clamps

FE640, FH210 equipped with a 4M50 engine assembly

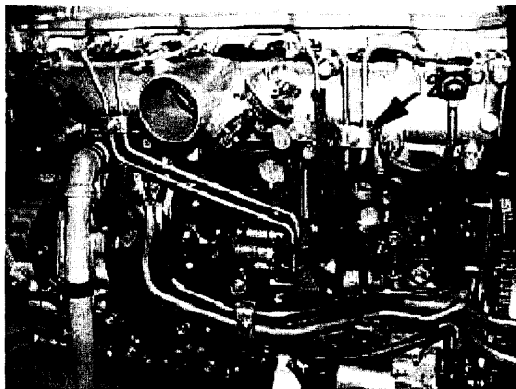
PHOTO 1

Mitsubishi Fuso Truck of America, Inc. has decided that a defect which relates to motor vehicle safety exists in the rubber portion of the fuel injection pipe clamps. On affected vehicles, the rubber portion of the clamp could deteriorate, causing the clamp to loosen and drop. If this condition occurs in the area of the fuel injection pump, the engine starter could short circuit if the clamp drops onto the starter terminal. This could prevent the engine from starting. In the worst case, excessive heat from the short circuit could cause a fire.

3. Remove the outer clamp at location 1 (as shown in PHOTO 1).
4. Install a new outer clamp (**MH020293**).
5. Apply a small amount of **Loctite 242 (or equivalent)** threadlocker on the threads of the existing stud.
6. Install a new spring washer (**MF450404**) and nut (**MF430004**) and tighten to **3.0 to 4.4 ft.lbs. IMPORTANT! DO NOT OVERTIGHTEN THE NUT!**
7. Clean off all excess adhesive.
8. Ensure that the thickness (**A**) of the assembled clamp is **0.81" to 0.85" (20.5 to 21.5mm)** after tightening (as shown in PHOTO 2). Repeat steps 3 to 6 if the measurement is outside of this specification.
9. Do not tighten or loosen the nut after proper specifications have been achieved. Loctite 242 cures to proper break-away strength after 24 hours.

10. Repeat steps 3 to 9 for the outer clamp at location 2.
11. Remove the outer clamp at location 3 (as shown in PHOTO 1).
12. Install a new outer clamp (**MH020293**).
13. Install a new bolt & washer assembly (**MH001852**) and tighten to **3.0 to 4.4 ft.lbs. IMPORTANT! DO NOT OVERTIGHTEN THE BOLT!**
14. Ensure that the thickness (**A**) of the assembled clamp is **0.81" to 0.85" (20.5 to 21.5mm)** after tightening (as shown in PHOTO 2). Repeat the steps 11 to 13 if the measurement is outside of this specification.
15. Do not tighten or loosen the bolt after proper specifications have been achieved. The yellow adhesive coating on the bolt threads cures to proper break-away strength after 6 hours.
16. Repeat steps 11 to 15 for the outer clamp at location 4.
