Dealer Service Instructions for:

## **Safety Recall D40 – Reroute Battery Cable**

**2004 (HB) Dodge Durango**

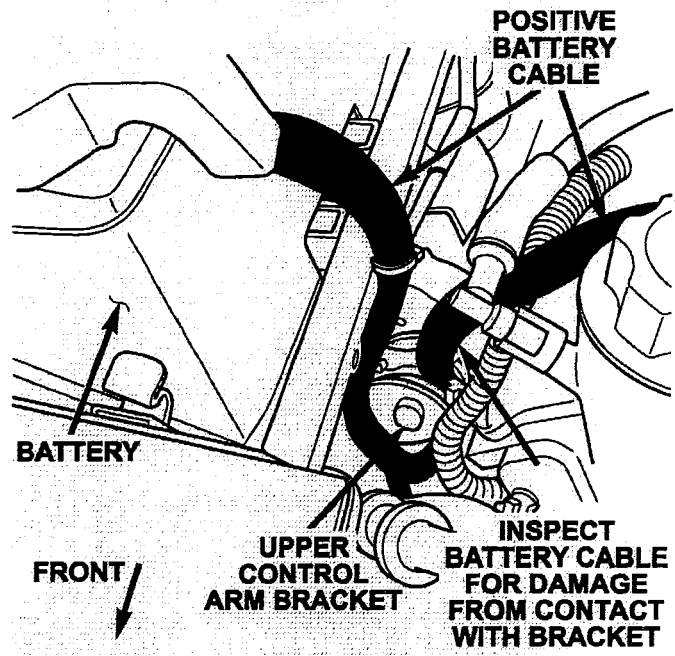
**Figure 1 – 4.7L Shown**

5. Inspect the positive battery cable where it passes the right upper control arm bracket (Figure 1). If the wiring insulation is damaged from contact with the bracket, wrap it with high quality electrical tape. If the battery cable copper wiring strands are visible, the battery cable must be replaced (P/N 56049174AI (4.7L), 56049175AI (5.7L) or 56049456AI (3.7L)).

**NOTE:** The positive battery cable must be secured with a tie strap even if the cable has been replaced.
