Reference: NHTSA Identification Number 04V-579

Dealer Service Instructions for:

Safety Recall D55 – Right Steering Knuckle

2005 (JR) Dodge Stratus Sedan and Chrysler Sebring Sedan/Convertible

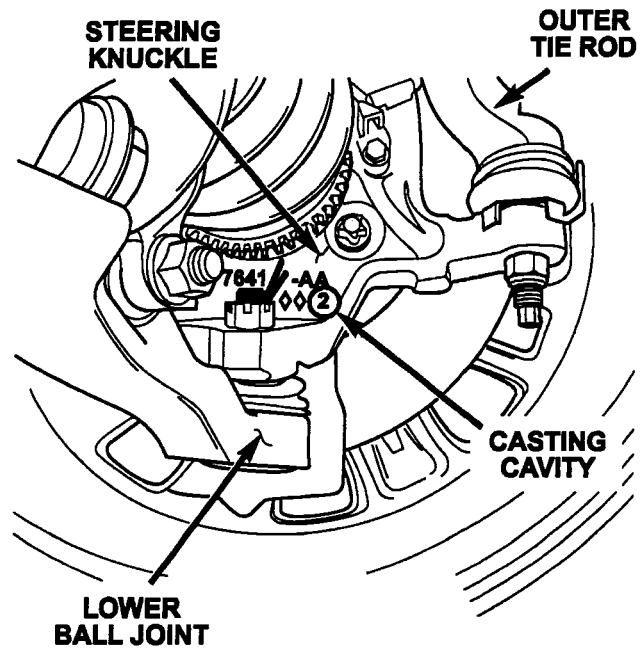
Figure 1

The right steering knuckle on about 26,000 of the above vehicles may have been improperly manufactured and could break. This may cause a loss of steering control and result in a crash without warning.

1. Raise the vehicle on an appropriate hoist.
2. Inspect the right steering knuckle casting cavity identification code (Figure 1).
3. ➤ **If the cavity code is a “2”, the steering knuckle must be replaced.** Continue with Section B – Replace Right Steering Knuckle.
- **If the cavity code is “1”, “3” or “4”,** no further action is required. Lower the vehicle and return it to the customer.

The right steering knuckle must be inspected and replaced if necessary.
