Volkswagen of America, Inc.

**Subject: Safety Recall VX
2000-2002 Model Year Volkswagen Jetta, Golf and GTI Vehicles
Replace Emergency Light Switch (Hazard Switch)**

Safety Recall Circular

Code: **VX**

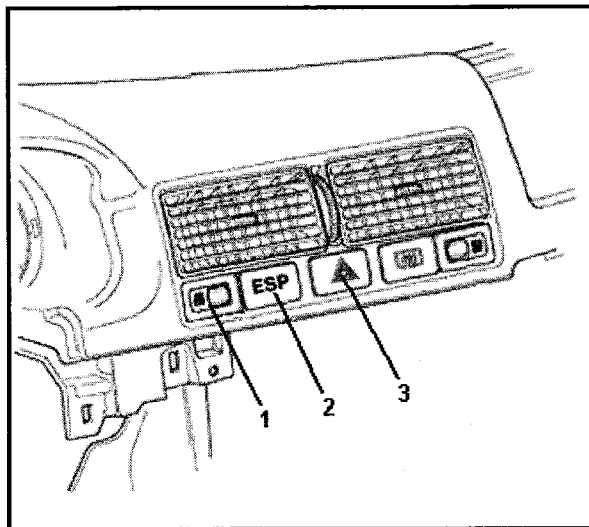
Section A – Emergency Light Switch Replacement

- Switch off all electrical consumers and remove key from ignition switch
- ← Emergency light switch -3- is the center switch in the instrument panel
- To remove emergency light switch, the ESP or ASR switch -2- must be removed, and to remove the ESP or ASR switch, the seat heater switch - 1- must be removed
- ← If an ESP or ASR switch -2- is located next to the emergency light switch, **go to Section B**; otherwise, continue
