**Subject: Recall Campaign VY (04V-586)
2004-2005 Model Year Volkswagen Jetta and Jetta Wagon,
Golf and New Beetle with 1.9L TDI-PD (Pumpe-Düse) Engine
2004-2005 Model Year Volkswagen Passat with 2.0L TDI-PD (Pumpe-Düse) Engine
Check/Install Diesel Pump Kit**

Safety Recall Circular

Code: **VY**

**Subject: 2004-2005 Model Year Volkswagen Jetta and Jetta Wagon,
Golf and New Beetle with 1.9L TDI-PD (Pumpe-Düse) Engine
2004-2005 Model Year Volkswagen Passat
with 2.0L TDI-PD (Pumpe-Düse) Engine
Check/Install Diesel Pump Kit**

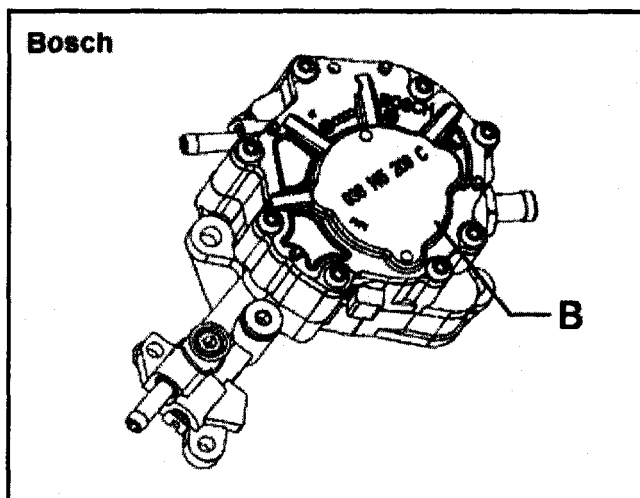
- Open hood
 - Using a flashlight and a mirror, check the type of tandem pump located at the rear of the cylinder head
- ⇐ If the tandem pump has a cast aluminum cover -B- with part number 038 145 209 C, the manufacturer is Bosch. No further work is required, close hood

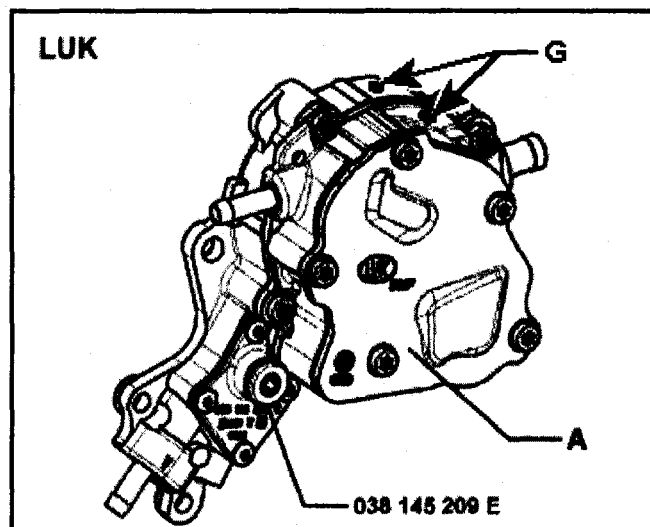
- ⇐ If the tandem pump has a black steel cover -A- with a part number 038 145 209 F, the manufacturer is LUK
- ⇐ Check the tandem pump housing for a green mark at either location -G-
- If there is a green mark, no further work is required, close hood
 - If there is no green mark, proceed to **Section B** for Golf and Jetta vehicles, **Section D** for Passat vehicles or **Section F** for New Beetle vehicles
