**Re: Defect Information Report (FL-436), NHTSA no. 04V-590  
Meritor 17N Series Interaxle Driveline**

**Section 573.6 Defect Information Report**  
**FL-436, NHTSA no. 04V-590**  
**Supplement No.: 1**

March 2005  
FL436A-U  
NHTSA #04V-590

## Subject: ArvinMeritor 17N Interaxle Driveline Male Shaft Yokes

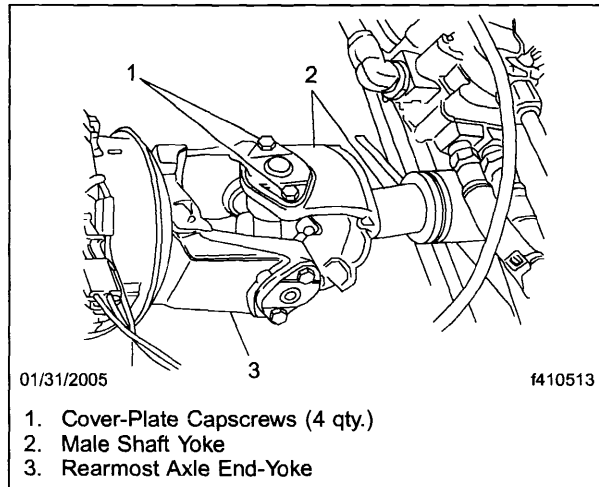
**Fig. 1, Cover-Plate Capscrews Location (one side of yoke shown)**

3. Remove and discard the four capscrews from the two cover plates of the male shaft yoke (two capscrews in each cover plate), attached to the rearmost axle end-yoke. See **Fig. 1**.
4. Try to insert the supplied pin gauge (p/n PNR6-32-18 from kit 25-FL436-000) into each of the four threaded holes on the cover plate of the male shaft yoke. See **Fig. 2**.

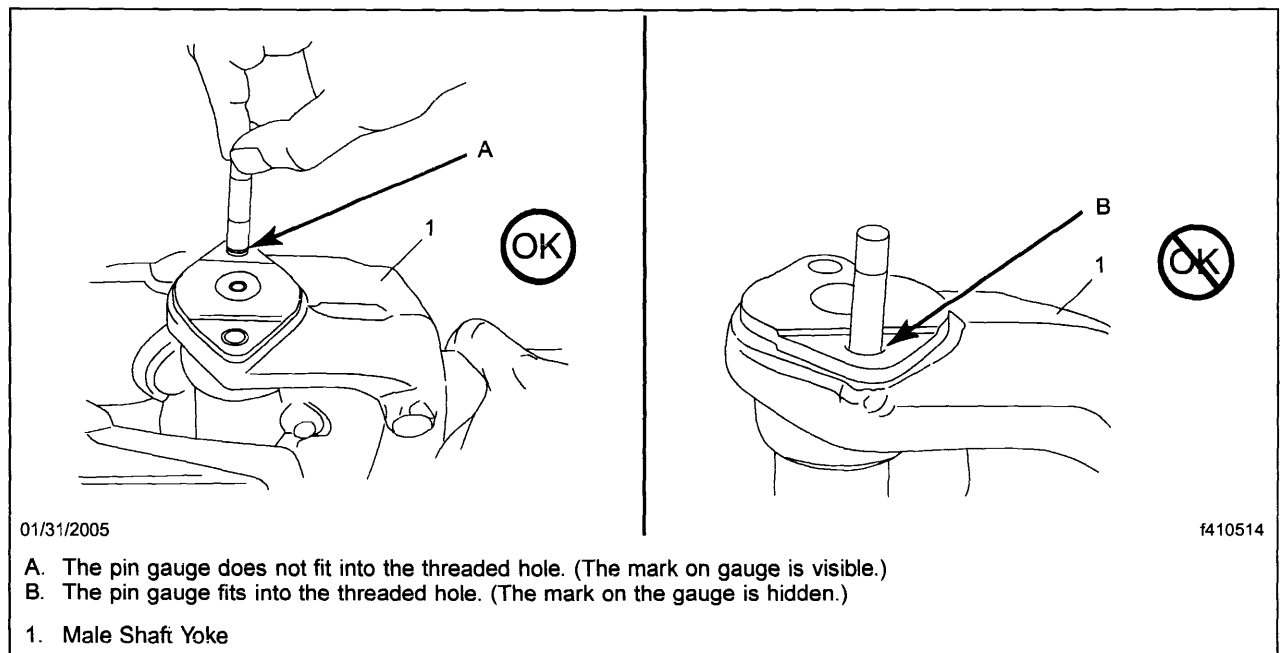
**Fig. 2, Checking the Capscrew Holes**

If the pin gauge *does* fit into any of the holes, the male shaft yoke must be replaced. Go to the "Yoke Replacement."

If the pin gauge does *not* fit into any of the holes, the male shaft yoke does not need to be replaced. Go to the next step.

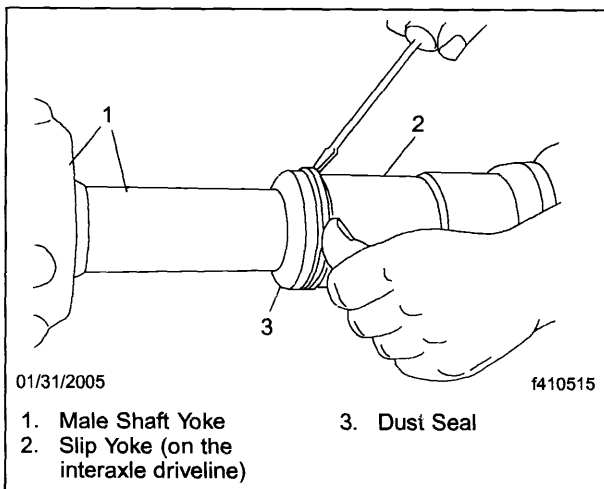
**Fig. 3, Removing the Dust Seal**

1. Remove the male shaft yoke.
  - 1.1 Using a suitable U-joint puller, disconnect the U-joint bearings from the rearmost axle end-yoke.
  - 1.2 Using a blade screwdriver, remove the dust seal from the slip yoke (on the interaxle driveline). See **Fig. 3**.
  - 1.3 Remove the male shaft yoke from the slip yoke. See **Fig. 4**.

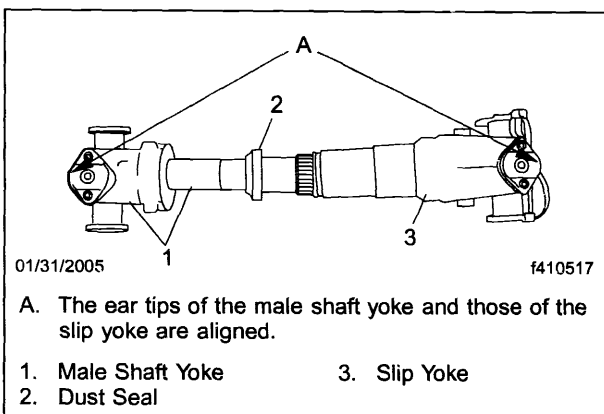
**Fig. 5, Correct Phasing of the Yokes**

2. Install the new male shaft yoke from the appropriate kit listed in Table 2 - Replacement Parts.
  - 2.1 Make sure the ears of the new shaft yoke and those of the slip yoke are phased correctly. The centerline of the male shaft yoke ear tips and the centerline of the slip yoke ear tips must be aligned with each other. See Fig. 5.
  - 2.2 Insert the new male shaft yoke (with the new dust seal and U-joint) into the splines of the slip yoke. Check again that the two yokes are phased correctly.

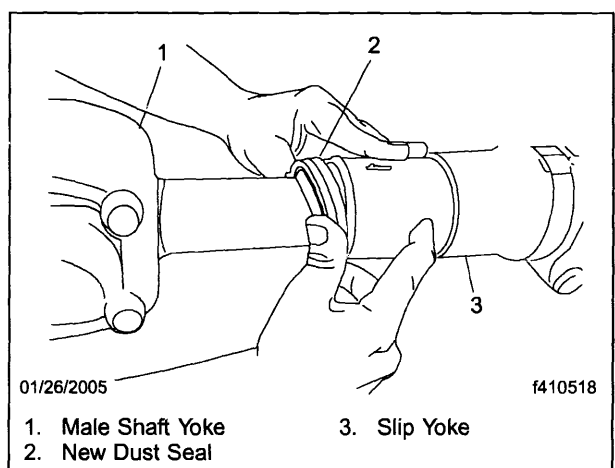
**Fig. 6, Installing the New Dust Shield**

- 2.3 Snap the dust seal over the end of the slip yoke. See **Fig. 6**.
- 2.4 Install the U-joint bearings in the rearmost axle end-yoke.
- 2.5 Install the new cover-plate capscrews on the rearmost end-yoke and tighten them as follows:
  - 38 to 48 lbf·ft (52 to 65 N·m) for a full-round yoke
  - 115 to 135 lbf·ft (156 to 183 N·m) for an Easy Service™ (half-round) yoke
