**Re: Defect Information Report (FL-437), NHTSA no. 04V-591**

**Section 573.6 Defect Information Report**  
**FL-437, NHTSA no. 04V-591**  
**Supplement No.: 1**

# Recall Campaign

## Subject: Brake Pedal Pushrod Jam Nuts

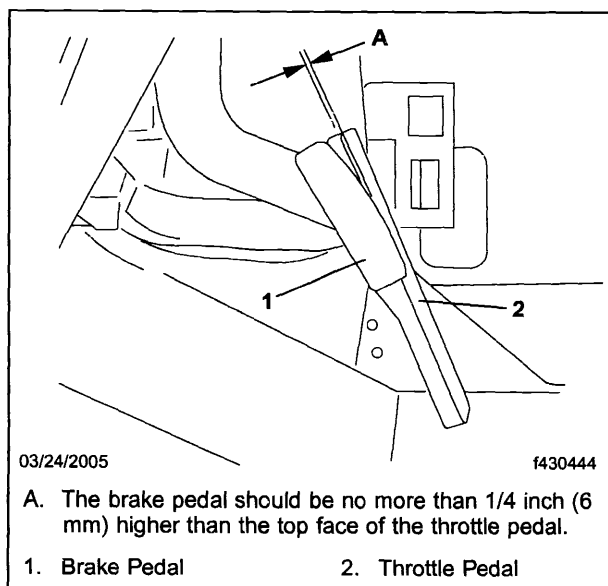
**Fig. 1, Pedal Position**

The jam nuts that secure the adjustment of the brake pedal pushrod may not be tightened properly. This could result in gradual loss in braking performance or a complete loss of brakes leading to a possible vehicle crash without prior warning.

5. Remove the carpet and backing from the driver-side floor area.
6. Adjust the brake pedal stop bracket to obtain a brake pedal position as shown in **Fig. 1**. The top face of the brake pedal should be flush with, or no more than 1/4 inch (5 mm) higher than, the throttle pedal.
