**Subject: Recall Campaign UY (04V-592)
2004-2005 Model Year Volkswagen Touareg Vehicles
Inspect Rear Outboard Seat Belts and, if Necessary, Install Belt Shortening Clips**

Compliance Recall Circular

**Subject: 2004-2005 Model Year Touareg Vehicles
Inspect Rear Outboard Seat Belts and, If Necessary,
Install Seat Belt Shortening Clip(s)**

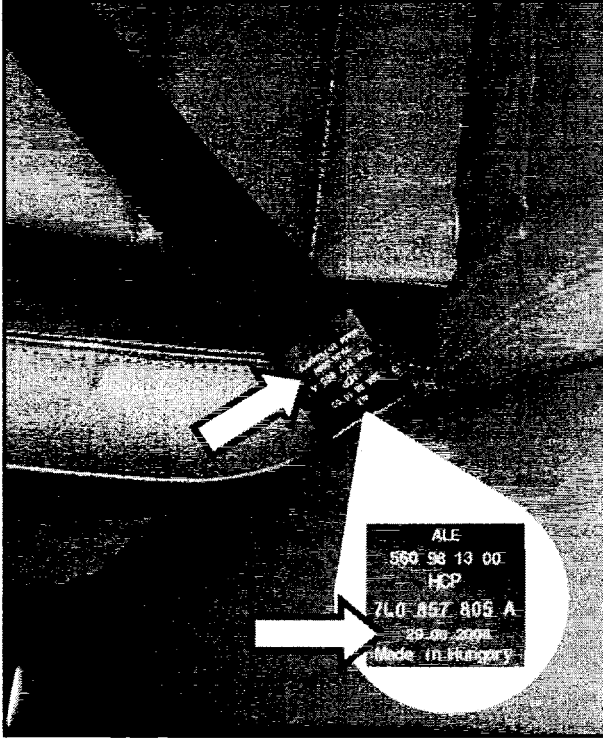
Section A – Check Rear Seat Belt Identification Label

- Open both rear doors
- ⇐ Illustration is showing left rear seat belt
- ⇐ Check the date -arrow- on the left and right outer rear seat belt labels;

- If the date is 07.08.2004 (**7 August 2004**) or later on the left and right seat belt label, no further work is required
- If the date is earlier then 07.08.2004 on either seat belt for proceed to Section B

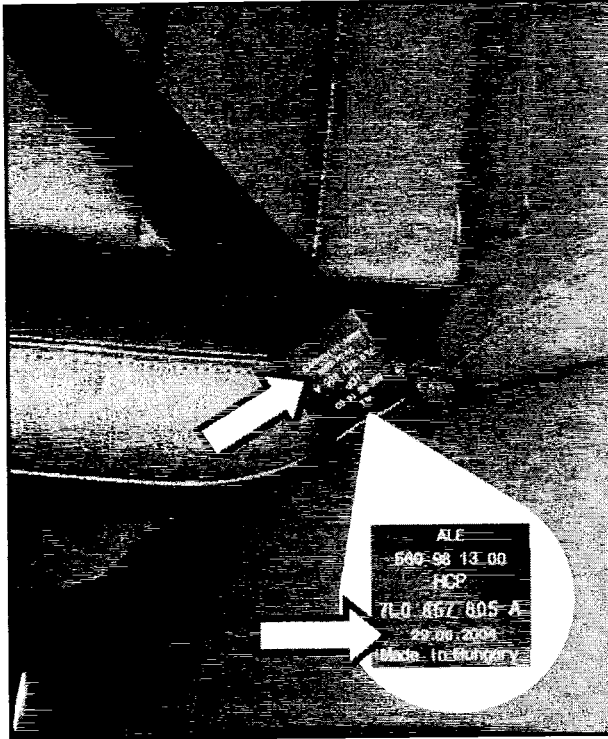
**Section A – Check Rear Seat Belt
identification label**

- Open both rear doors
- ⇐ Illustration is showing left rear seat belt
- ⇐ Check the date -arrow- on the left and right outer rear seat belt labels;

- If the date is 07.08.2004 (7 August 2004) or later, no further work is required
- If the date is earlier then 07.08.2004, the seat belt needs to be changed, proceed to Section B
