November 2004

**SUBJECT:** **Safety Recall 04S20: Supplement #1**  
All 2002 and Certain 2003 Model Year Ford 4-Door Explorer & Mercury Mountaineer Vehicles  
Liftgate Glass Hinge and Ball Stud Bracket (if applicable) Replacement

## CERTAIN 2002 AND 2003 MODEL YEAR EXPLORER/MOUNTAINEER VEHICLES — LIFTGATE GLASS BALL STUD BRACKET AND HINGE REPLACEMENT

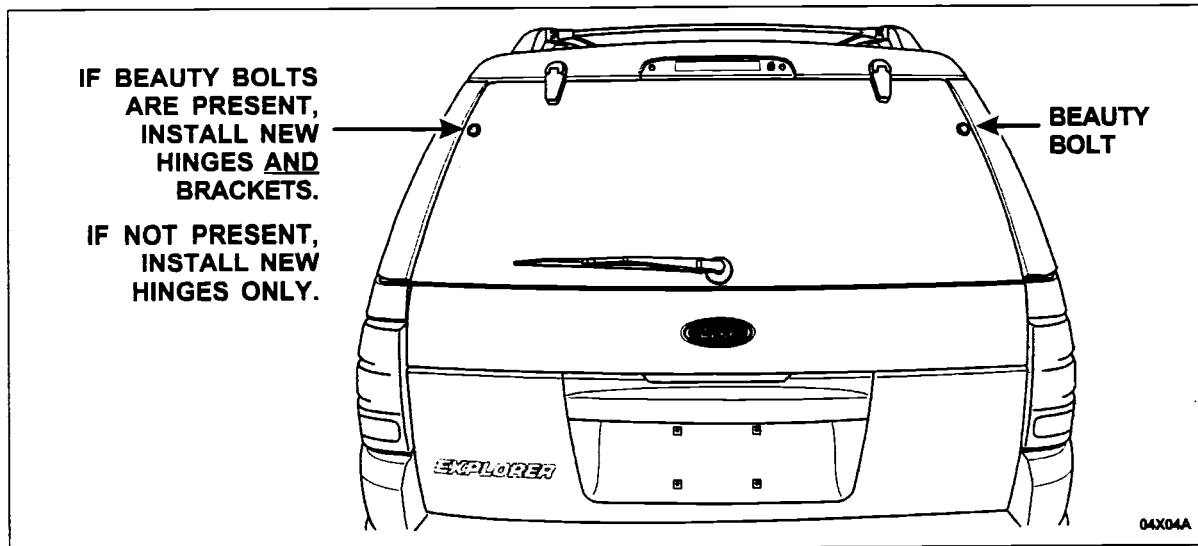
FIGURE 1

- Early 2002 models use ball stud brackets that are secured with beauty bolts, which pass through the glass (the head of the bolt is visible on the outside of the glass) and are bonded to the glass about 150 mm (6 inches) from the top of the glass. See Figure 1. If beauty bolts are present, both the liftgate ball stud brackets and hinges will be replaced. Perform BOTH the Liftgate Glass Hinge Replacement and the Ball Stud Bracket Replacement. Begin your repairs with LIFTGATE GLASS HINGE REPLACEMENT.
- Later built 2002 and 2003 model year vehicles use revised ball stud brackets which are not secured with beauty bolts. If beauty bolts are not present, only the hinges will be replaced. Perform only the LIFTGATE GLASS HINGE REPLACEMENT.

- On early built 2002 model year vehicles, the liftgate glass ball stud brackets and liftgate glass hinges require replacement.
- On later built 2002 and all early 2003 model year vehicles only the liftgate glass hinges require replacement.

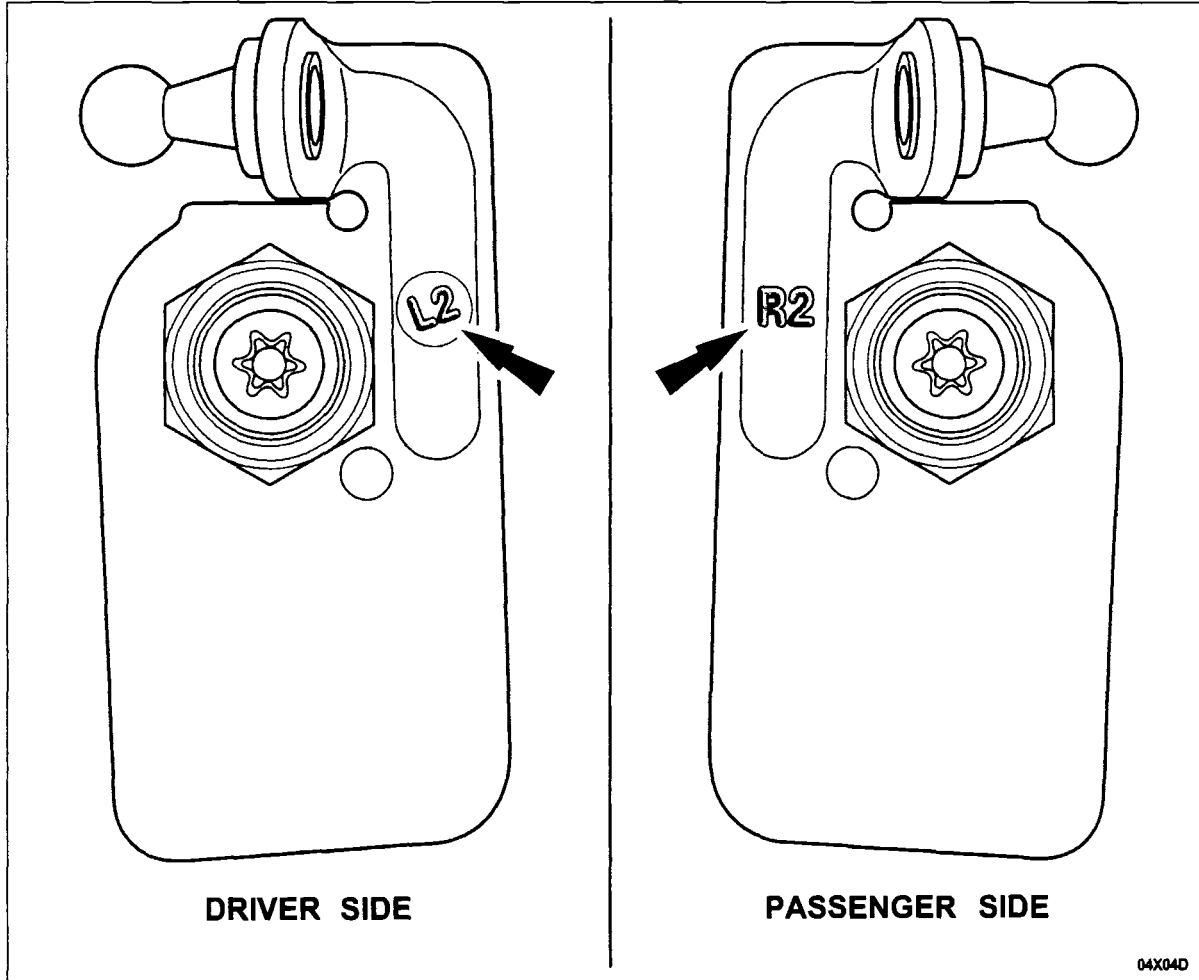
FIGURE 4

**NOTE:** The *new* brackets are marked with a stamping, L or R followed by a number. They are **NOT** interchangeable. The L is for the driver side of the glass and has left-hand threads. The R is for the passenger side of the glass and has right-hand threads. The number can be ignored. See Figure 4.

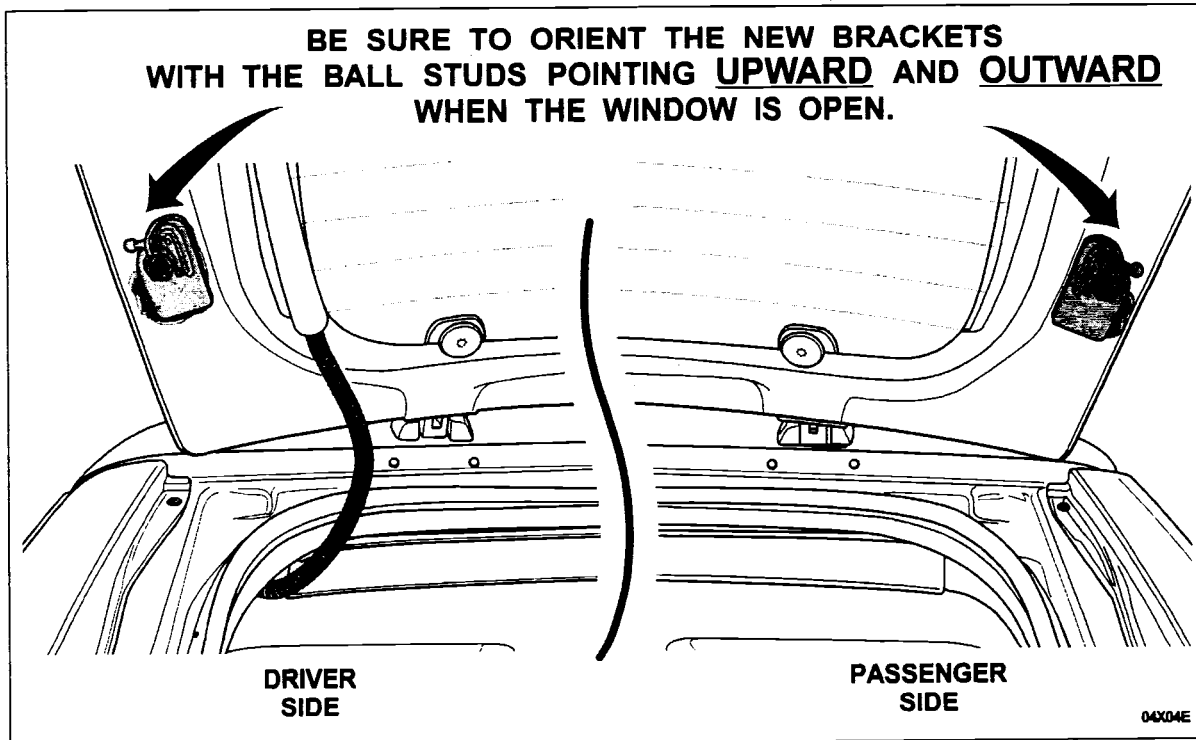
**FIGURE 5**

**NOTE:** With the liftgate glass open, be sure to properly orient the *new* brackets with the ball stud pointing upward and outward. See Figure 5.

3. Hold the **new** bracket in position on the glass with the ball stud pointing UP and OUT (with the liftgate glass open). Mark the area around the bracket using masking tape or vinyl tape. Leave a space approximately 7 mm ( $\frac{1}{4}$  in) between the edge of the bracket and the tape. The taped-off area should be approximately 57-mm ( $2\frac{1}{4}$  in) wide and 89-mm ( $3\frac{1}{2}$  in) high. See Figure 6 for proper placement and dimensions. After the tape is applied, remove the bracket. The tape will be used as an alignment guide, therefore, keep the tape in place until completing the final bracket alignment.

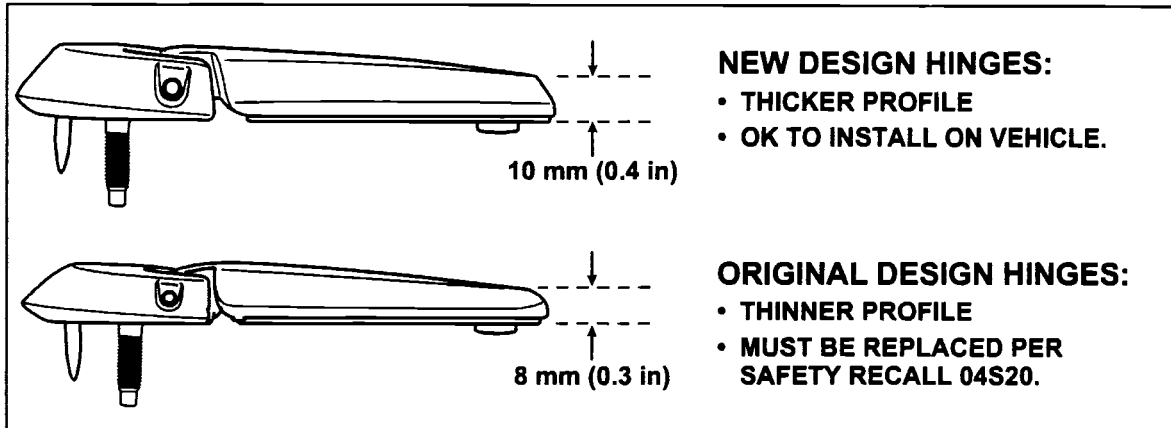
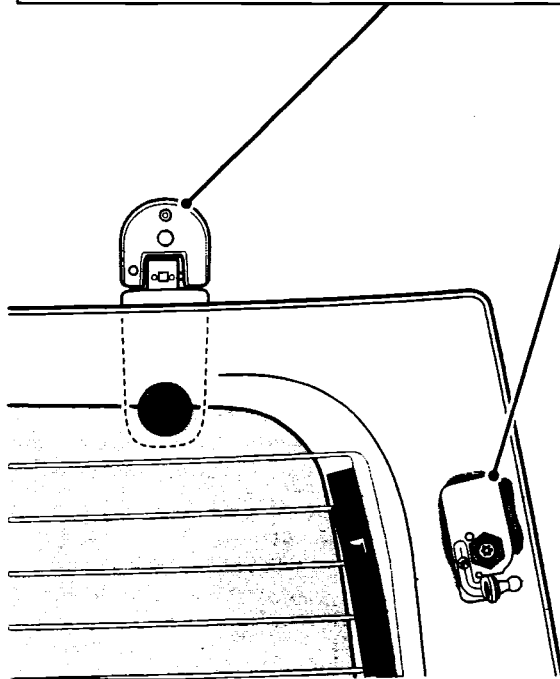
- INSPECT FOR SOFT ADHESIVE BY ATTEMPTING TO LEAVE IMPRESSIONS WITH FINGERNAIL.
- BRACKET MUST BE REPLACED PER SAFETY RECALL 04S20 IF ADHESIVE IS SOFT.
- BRACKETS OK IF ADHESIVE IS HARD.

- MUST BE REPLACED PER SAFETY RECALL 04S20.

**A12)** *In this situation, please review the illustration below to verify whether the replacement glass already has the latest level hinges, strut brackets and adhesive. This is necessary because your service glass supplier may not have provided the latest level glass assembly. If not, update the hardware and adhesive to the latest level.*

- The new design hinges.
- Large strut brackets.
- Hard adhesive.
