Mazda North American Operations

SUBJECT: 2004-2005 Tribute Lift Gate Latch Recall 2804L

TRIBUTE LIFTGATE LATCH [RECALL 2804L]

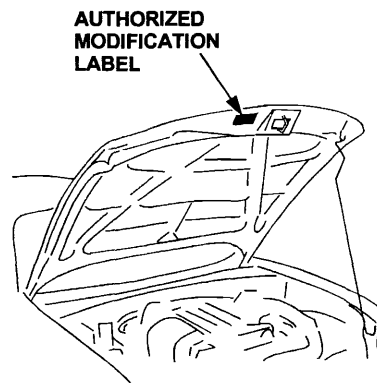
2. Perform a Warranty Vehicle Inquiry using your eMDCS System and inspect vehicle for an Authorized Modification Label **Recall 2804L** attached to the vehicle's hood. Refer to eMDCS System - Warranty Vehicle Inquiry Results table below.

Complete an "Authorized Modification Label" with the Recall number written on the sticker and affix it to the vehicle's hood. Refer back to the illustration under "A. VEHICLE INSPECTION PROCEDURE".
