Re: *SPX Filtran Fuel Filters*

PART 573 Report of Possible Defect

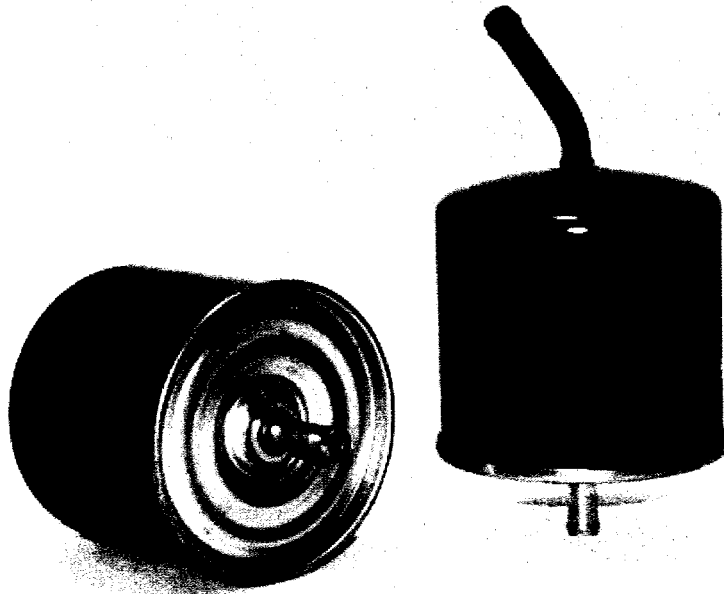
SPX FILTRAN MODEL NUMBER
800F350-S1:

The SPX Filtran Model "F350" fuel filter is distinguished by having a 45-degree angle on the inlet tube of the filter. (See photograph attached as Exhibit A.) The F350 fuel filter is an after-market replacement part used in certain vehicles manufactured by Ford and Mazda (Ford Probe 1993-1997 models; Mazda 1993-2001 models).

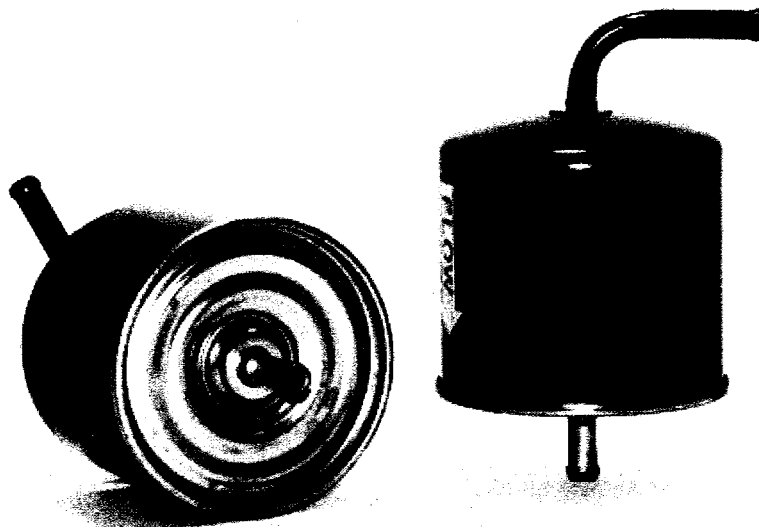
SPX FILTRAN MODEL NUMBER
800F300-S2:

The SPX Filtran Model "F300" fuel filter is distinguished by having a 90-degree angle on the inlet tube of the filter. (See photograph attached as Exhibit A.) The F300 fuel filter is an after-market replacement part used in Subaru automobiles with EFI or Turbo engines produced from 1983 through 1994.

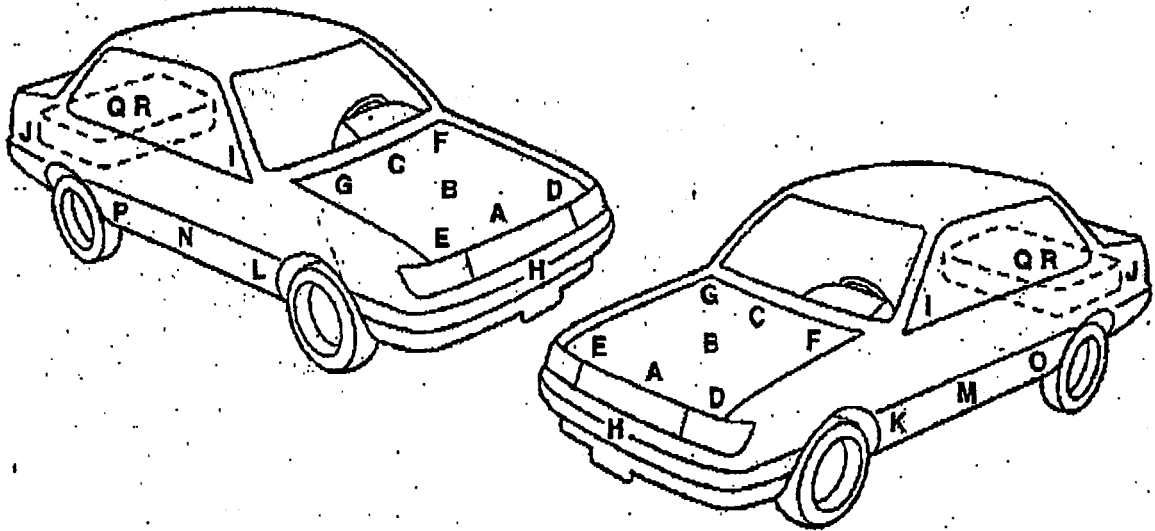
FUEL FILTER LOCATOR CHART

When installed, the fuel filter is located under the hood near the top rear of the engine, on the driver's side of the vehicle. (See illustration attached as Exhibit B. The location of the fuel filter is indicated by the letter F.)
