05V-018  
(10 pages)

File In Section: Product Recalls  
Bulletin No.: 05010  
Date: January 2005

**SUBJECT: INTERMEDIATE STEERING SHAFT TO STEERING GEAR BOLT**

**MODELS: 2005 CHEVROLET SILVERADO  
2005 GMC SIERRA**

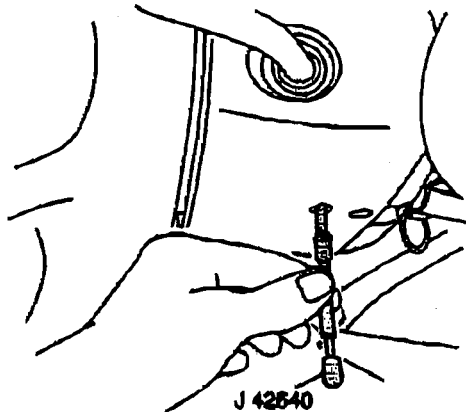
333148

General Motors has decided that a defect, which relates to motor vehicle safety, exists in certain 2005 Chevrolet Silverado and GMC Sierra vehicles. The bolt that attaches the intermediate steering shaft to the steering gear may not meet specification. The bolt may fracture, resulting in the loss of steering. If this happens while the vehicle is moving, a crash could occur without prior warning.

2. Install J 42640 in the steering column lower access hole.
3. For vehicles equipped with a 6.6L diesel engine, remove the left charge air cooler hose.
4. Remove the bolt from the lower shaft coupler.
5. Install the new bolt to the lower shaft coupler. **Tighten**

Tighten the coupler pinch bolt to 47 N·m (35 lb ft).
