American Honda Motor Co., Inc.
1919 Torrance Boulevard
Torrance, CA 90501-2746
Phone (310) 783-2000

February 2, 2005

On January 27, 2005, Honda Motor Co., Ltd. (HMC) determined that a defect relating to motor vehicle safety exists in the motor vehicles listed below, and is furnishing notification to the National Highway Traffic Safety Administration in accordance with 49 CFR Part 573 Defect and Noncompliance Reports.

The steering column may be incorrectly assembled, which could result in a loss of steering control. A loss of steering control can cause a crash without warning.

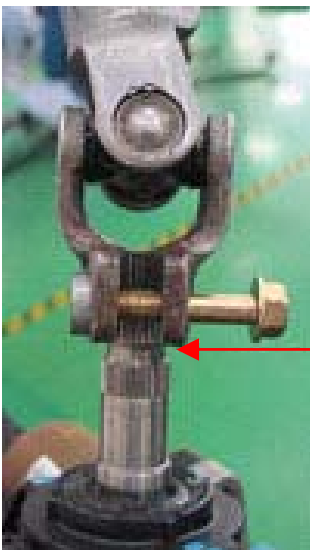
A universal joint connects the steering column to the steering gearbox. The bolt that fastens the joint to the gearbox shaft may be mispositioned. A retention groove in the shaft positions the bolt to securely fasten the joint. If the bolt does not engage the shaft at this groove, the column could separate from the gearbox. If separation occurs, steering control will be lost without warning, which can cause a crash.

INCORRECT ASSEMBLY SHOWN.
Bolt should be aligned with the retention groove.

| Jan. 24, 2005 | HMA investigated manufacturing records and found that a new associate trainee assembled all four vehicles identified with mispositioned steering yoke bolts. HMA informed AHM. |

The owners of all affected vehicles were notified by telephone and asked to stop driving their vehicle. All vehicles will be towed to a Honda dealership for inspection. The center shaft yoke bolt was removed to determine whether it was installed correctly. If the bolt was not installed correctly, the parts will be examined for damage and replaced if necessary. The joint will be reassembled in the correct position. The inspection and any necessary repairs were performed free of charge for all affected vehicles.
