**From:** St-Cyr Francis  
**Sent:** Monday, February 14, 2005 3:43 PM  
**To:** Cooke, Barbara  
**Cc:**  
**Subject:** Reference EQ05-002  
**Importance:** High

**Urresko Clamp Replacement Procedures and Instructions**  
**CL2225 Clamp**  
**Revision Date: 12/7/04**

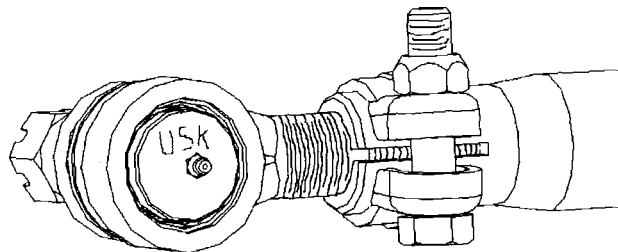
**Verify that the tie rod assembly is manufactured by Urresko. There is a USK stamped into the ball stud cover. See figure Below:**

If the tie rod assembly is verified not to be Urresko, clamp change out is not required. Record vehicle vin number and axle serial number and other data as required to verify inspection was completed.

If the tie rod assembly is verified to be Urresko, both the left and right side clamps require replacement. Go to Step 2-Clamp Replacement.
