05V-132
(3 pages)

On March 21, 2005, Honda Motor Co., Ltd. determined that a defect relating to motor vehicle safety exists in the motor vehicles listed below, and is furnishing notification to the National Highway Traffic Safety Administration in accordance with the requirements of 49 CFR 573.6.

Defect description:

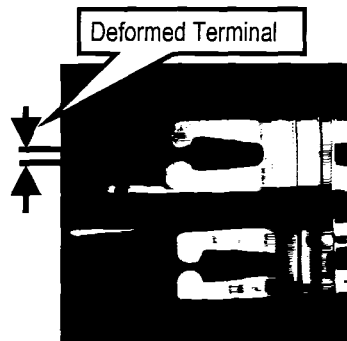
A loose terminal in the main fuse box may cause the fuel pump to lose power. If the fuel pump becomes inoperative, the engine may not start. In the worst case, if the fuel pump loses power while driving, the engine could stall without warning, and a crash could occur.

Due to a broken die punch, some terminals used in the main fuse box may have been deformed. A deformed terminal will not provide adequate contact with the fuel pump relay. Poor contact can result in intermittent power loss to the fuel pump, and the engine will be difficult to start. In the worst case, the engine could stall without warning, and a crash could occur.

The owners of all affected vehicles will be contacted by mail and asked to take their vehicle to a Honda or Acura dealer. The dealer will replace the entire fuse box, free of charge.
