The following information is submitted pursuant to the requirements of 49 CFR 573.6 as it applies to a determination by General Motors of a safety defect involving certain 2005 Buick LaCrosse vehicles.

# Recall Bulletin

**SUBJECT: BRAKE PEDAL PUSHROD RETAINER**

**MODELS: 2005 BUICK ALLURE, LACROSSE**

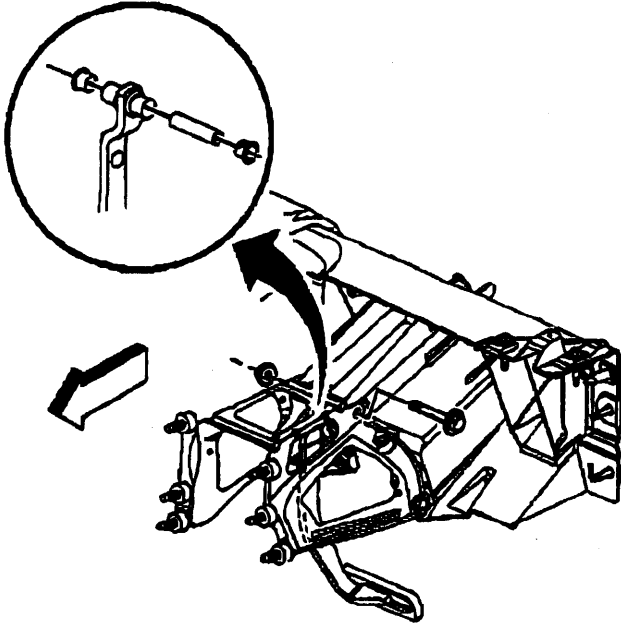
630032

1. Unplug and remove the brake pedal position sensor.
2. Remove the brake pedal pushrod and bushing from the brake pedal.

3. Remove the brake pedal nut and bolt.

**Important: It is not necessary to completely remove the bolt from the bracket. Leaving the bolt slightly engaged will assist in re-assembly.**
