GENERAL MOTORS NORTH AMERICA
 Structure & Safety Integration

05V-158
 (14 Pages)

RECALL BULLETIN

SUBJECT: INSTALLATION OF REAR SEAT CENTER BELT ANCHOR REINFORCEMENT PLATE

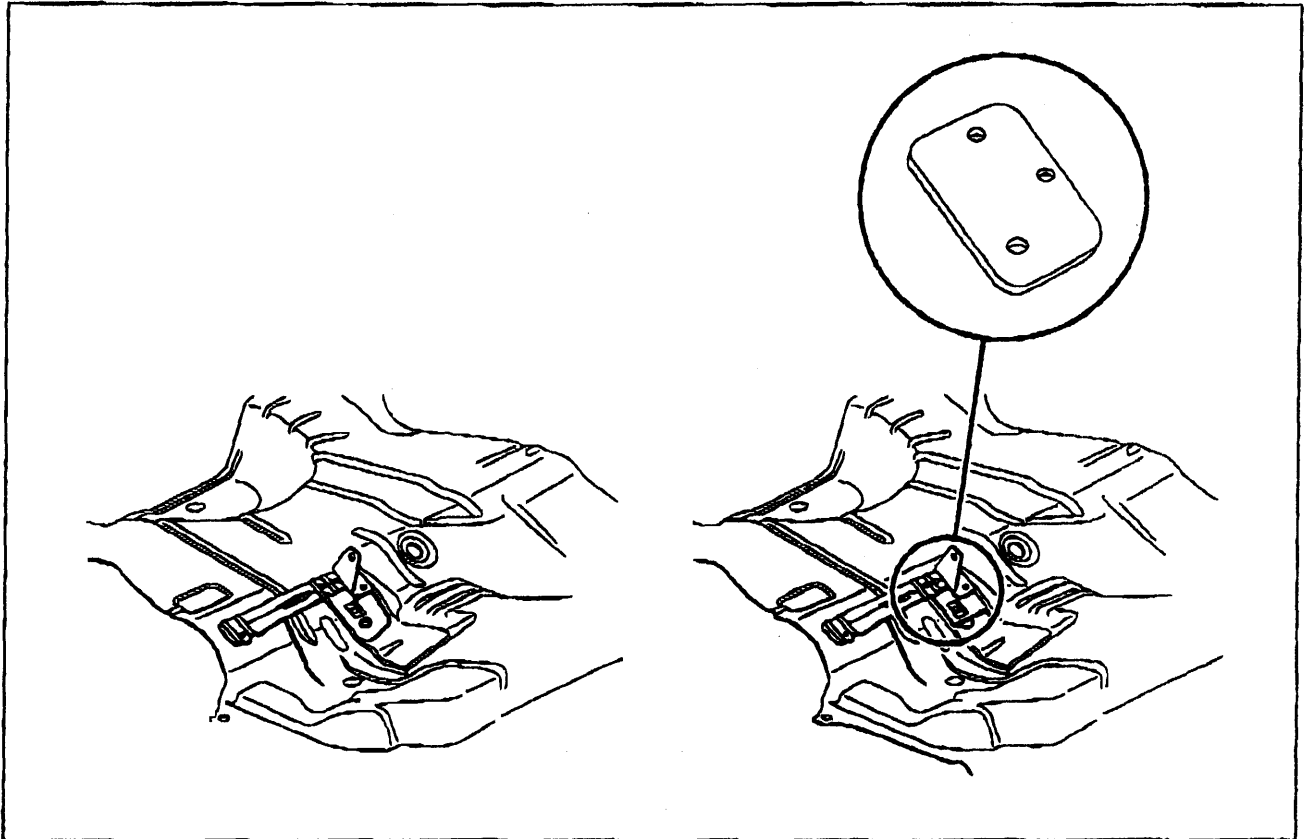
Refer to the illustration below to view the floor pan, child seat anchor plate, and rear seat center belt anchor reinforcement plate.

In order to install the rear seat center belt anchor reinforcement plate to the floor pan of the vehicle, removal of the following interior parts is required: rear seat cushion, passenger side rear folding seat back, two 8 mm (0.315 in) child seat anchor plate assembly bolts, one 11.11 mm (7/16 in) seat belt anchor bolt, and a fiber retainer (if applicable) and buckle/latch assembly. No special tools are required to perform the service procedures in this bulletin.
