Re: American IronHorse Motorcycle  
Company, Inc.

## PART 573 DEFECT REPORT

## **TECHNICAL ADVISORY**

**Subject: Progressive Shock Inspection**

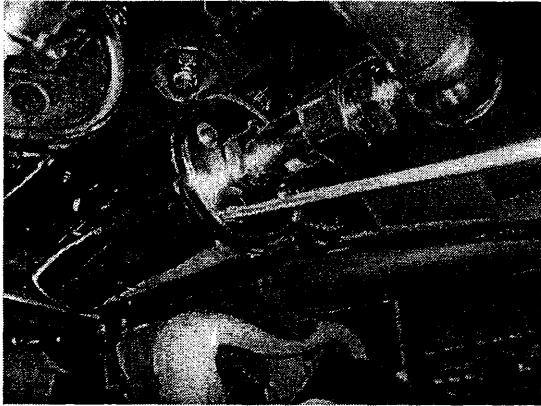
Figure 1

Softtail non-air ride motorcycles delivered after 01-15-2005 may be equipped with defective Progressive® shocks.

A defective shock can fully extend without warning creating a hazardous riding condition.

1. With the motorcycle on floor in the upright position insert the pin from the tail end of the caliper, into one of the four (4) holes in the face of the shock (Figures 1 and 2). The measured distance to the spring plate inside the shock shall not exceed 1.2 inches.
2. If you have identified a potentially bad shock please remove this motorcycle from your available stock. **DO NOT** ride or sell this motorcycle. Contact American IronHorse Motorcycle Company at 1-888- 618-4766 and provide the VIN # of the subject motorcycle. The replacement shock(s) will be provided by the manufacturer.
