## NONCOMPLIANCE INFORMATION REPORT

Van Hool N.V. has determined that a noncompliance with S5.1 of Federal Motor Vehicle Safety Standard No. 217 may exist in certain Model Year 2000 and 2001 Van Hool commuter coaches manufactured between September 1999 and September 2000. The potential noncompliance results from a possible mismatch between components of the emergency window latching system of certain Van Hool coaches.

**Re: NHTSA Safety Recall, Campaign number \_\_\_\_\_  
Van Hool Coaches type C2045**

# SERVICE BULLETIN No.P329

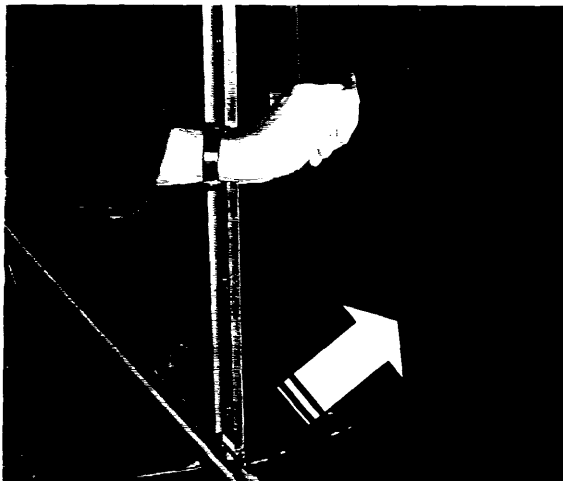
**Figure 1: Opening the passenger emergency window**

- 1) Working inside the coach, open the window by pulling the emergency release handle (see Figure 1).

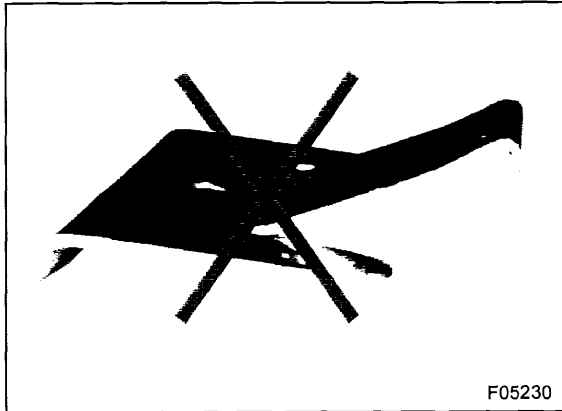
- 2) Identify the type of catch (see Figures 2 and 3), which have been attached to the bottom channel of the window frame. All single leaf catch types should be replaced.

**Figure 2: Single leaf catch type should be replaced**

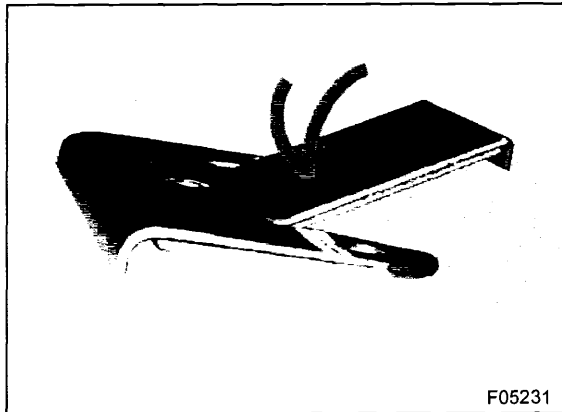
**Figure 3: Twin leaf catch type should replace single leaf type**

- 3) If a wrong type catch has been installed, remove the old one and install a twin leaf type referring to Figures 4 and 5.
