**Re: Thor California, Inc. Recall
Defect and Non-Compliance Report**

THOR CALIFORNIA**RECALL SERVICE BULLETIN**

**Axle Spring Hanger Enhancement
(2-Axle Units Only)**

2004/05 Tahoe 36WTB FW
2004/05 Wanderer 367WTB FW
2004/05 Jazz 36WTB FW
built from July 2003 through October 2004

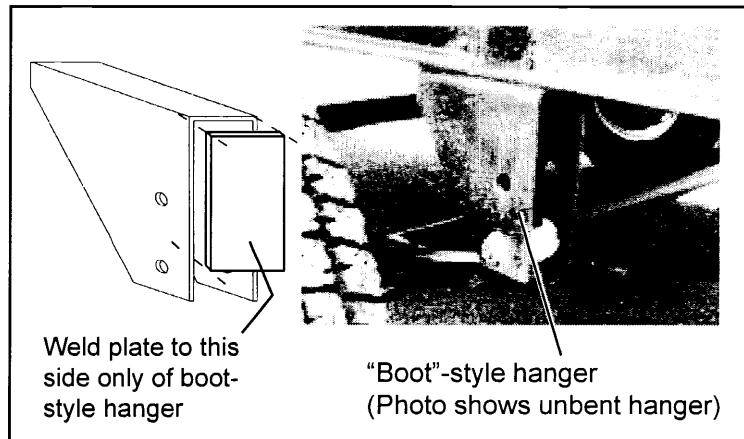
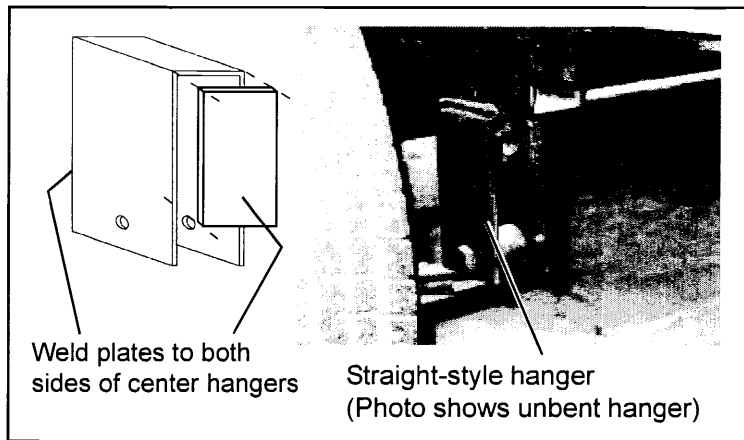
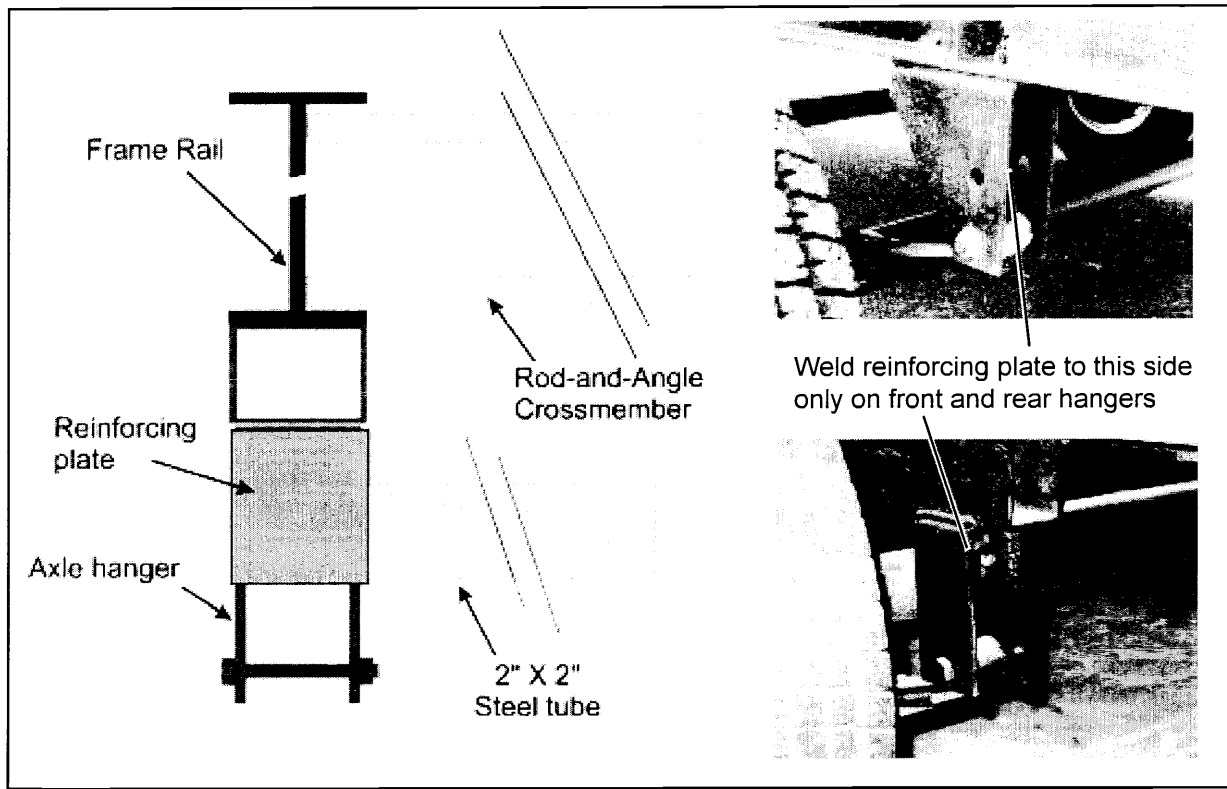
Under certain conditions, extreme side-loading of the axles may cause the axle hangers to become permanently bent. Repeated or extreme bending may also cause permanent bending of the frame rails, and misalignment of the axles and trailer chassis.

3. Straighten axle hangers as necessary. Reinforce the front and rear hangers by welding a $2\frac{3}{4}$ " X 4" X $\frac{1}{4}$ " steel plate to the the side of the hanger away from the axle. The plate should overlap the outside of the hanger by approximately $\frac{1}{8}$ " on each side. Reinforce the center hangers by welding $2\frac{3}{4}$ " X 4" X $\frac{1}{4}$ " steel plates to both sides of the hangers.

5. After all six hangers have been replaced or straightened and reinforced, weld the three 2" X 2" steel tube cross ties between the axle hangers. Trim the tube sections to fit as required.
