GILLIG CORPORATION

05V-271
(8pages)

Safety Defect and Noncompliance Report Guide for Vehicles
PART 573 Defect and Noncompliance Report¹

Gillig Low Floor Bus Front Axle Rod Removal and Installation Procedures

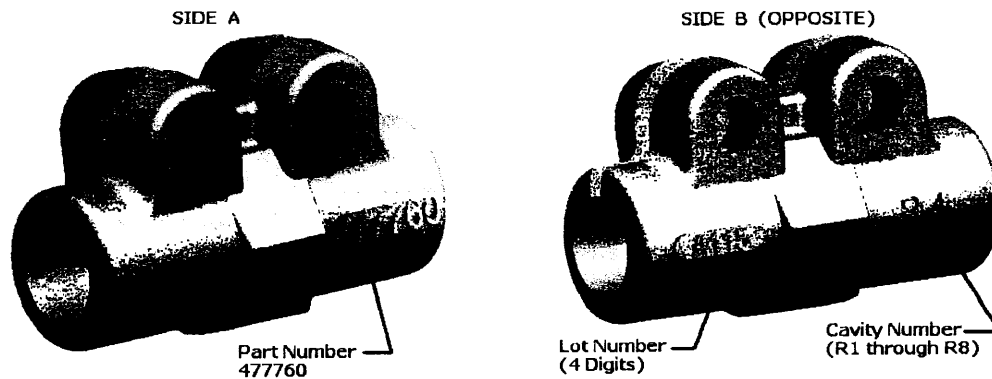
Figure 1: Clamp Identification Aid

- A list of buses by VIN that potentially have suspect clamps accompanies this notice. Only buses that match these VIN numbers will have to be inspected.
- All rods with suspect clamps will be located on the front suspension only. No rear rods are involved.
- Suspect clamps can only be identified by using the markings on the cast clamp located in the center of the rod.
- Identification should be performed while the rod is still installed on the vehicle.
- Castings are identified by a raised part number 477760 cast in them on one side and a cavity number and lot number beginning with a letter followed by 3 numbers (X ___) on the other. See Figure 1.
- Some vehicles may not have any rods on them that meet the recall requirements. Others could have just one, or up to all 4 rods, that meet the requirements for replacement.

After the bus is put on a lift where the rods can be easily accessed and inspected, the suspect clamps can be identified as noted in the attached photo (Figure 1).

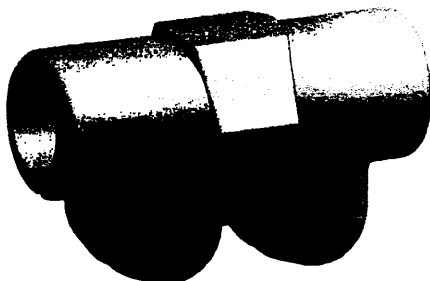
Figure 2: Identification Aid for Clamps Not Included in the Recall

Not included in the recall are rods with clamps having the part number 477762 cast in them. These clamps can also be identified with a cavity number ending in the letter S and a 4 digit numerical lot number. Unlike the recalled clamps, these clamps will have all of the identification marking cast into the part on the same side. See Figure 2
