**Re: Defect Information Report – supplemental information
(FL-453), NHTSA no. 05V-284, Holland AD Rear Suspension**

Section 573.6 Defect Information Report
FL-453, Holland AD Suspension; NHTSA no. 05V0284
Supplement No.: 01

Subject: Holland AD Series Transverse Beam End Castings

TRANSVERSE BEAM REPLACEMENT AND RETURN PROCEDURE MANUAL

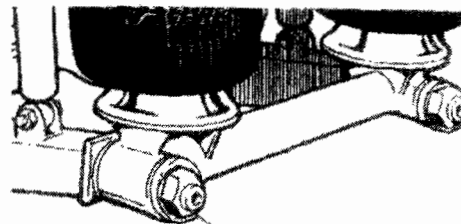
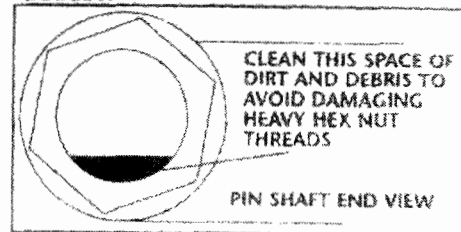
Figure 2

CLEAN THIS SPACE OF DIRT AND DEBRIS TO AVOID DAMAGING HEAVY HEX NUT THREADS

1. Clean the fasteners and pin shafts of the Transverse Beam connections prior to disassembly to help protect the threads.
2. Clean out the space between the Pin Shaft and the Heavy Hex Nut to remove dirt and debris. A piece of wire can help loosen trapped debris (Figures 2 and 4).
