# MID BUS

Please find the following 573 form and the documentation that was sent to us from Specialty Manufacturing. This 573 form is for the Specialty Manufacturing Recall on their "5" Series Stop Arms.

Safety Defect and Noncompliance Report Guide for Vehicles  
**PART 573 Defect and Noncompliance Report**<sup>3</sup>

Subject: Defect Information Report relating to certain model stop arms shipped to Mid-Bus Corporation between January 1, 2002 and March 1, 2005.

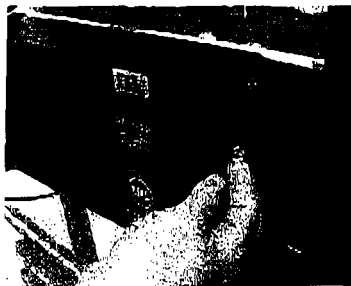
15. Heater inspection and electrical connection- In order for the new switches to operate properly, the heater must be wired to a 12v source that is controlled by the ignition switch. Inspect bus heater wiring to verify. If heater is not connected to the ignition circuit, there are two possible wiring configurations to achieve this:

LEAVE THIS SECTION UNSEALED

- a) on full size buses, route the yellow wire from the heater into the electrical access panel located just in front of the stop arm. In this panel connect the heater to a switched electrical circuit such as "IGNITION ASSY"
- b) On "cutaway" buses, use the snap connector included with the switch kit to connect the yellow wire from the heater to the double red wire in the stop arm. After doing this, the red wire (12v+) coming into the stop must be reconnected to a switched ignition source.

16. Replace cover. Secure with (2) screws. Reseal both ends of the crossing arm cover with RTV. **IMPORTANT! - DO NOT seal approximately 1" of the lower right side of the box. This provides an additional drainage location.**
