05V-342

RE: Defect Information Report

Technical Service Bulletin

Subject
REPLACEMENT OF PARKING BRAKE LEVER ASSEMBLY (RECALL)

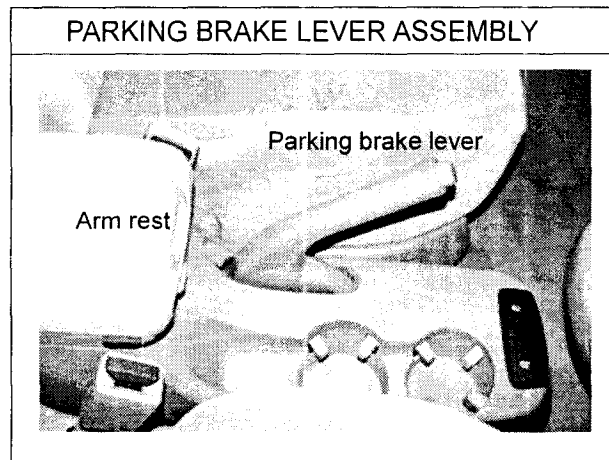
Certain TUCSON(JM) vehicles were produced with the pawl of a parking brake lever assembly that was incorrectly manufactured.

Improperly manufactured parking brake lever pawl may cause the parking brake lever not to engage when applying the lever.

Correct the above condition by replacing the parking brake lever assembly with a new one in accordance with the service procedure below.
