NEW FLYER

Subject: Safety Recall – Flange Fitting Assembly - New Flyer Part Number 063052.

05V-370
(11 pages)

Safety Defect and Noncompliance Report Guide for Vehicles
PART 573 Defect and Noncompliance Report¹

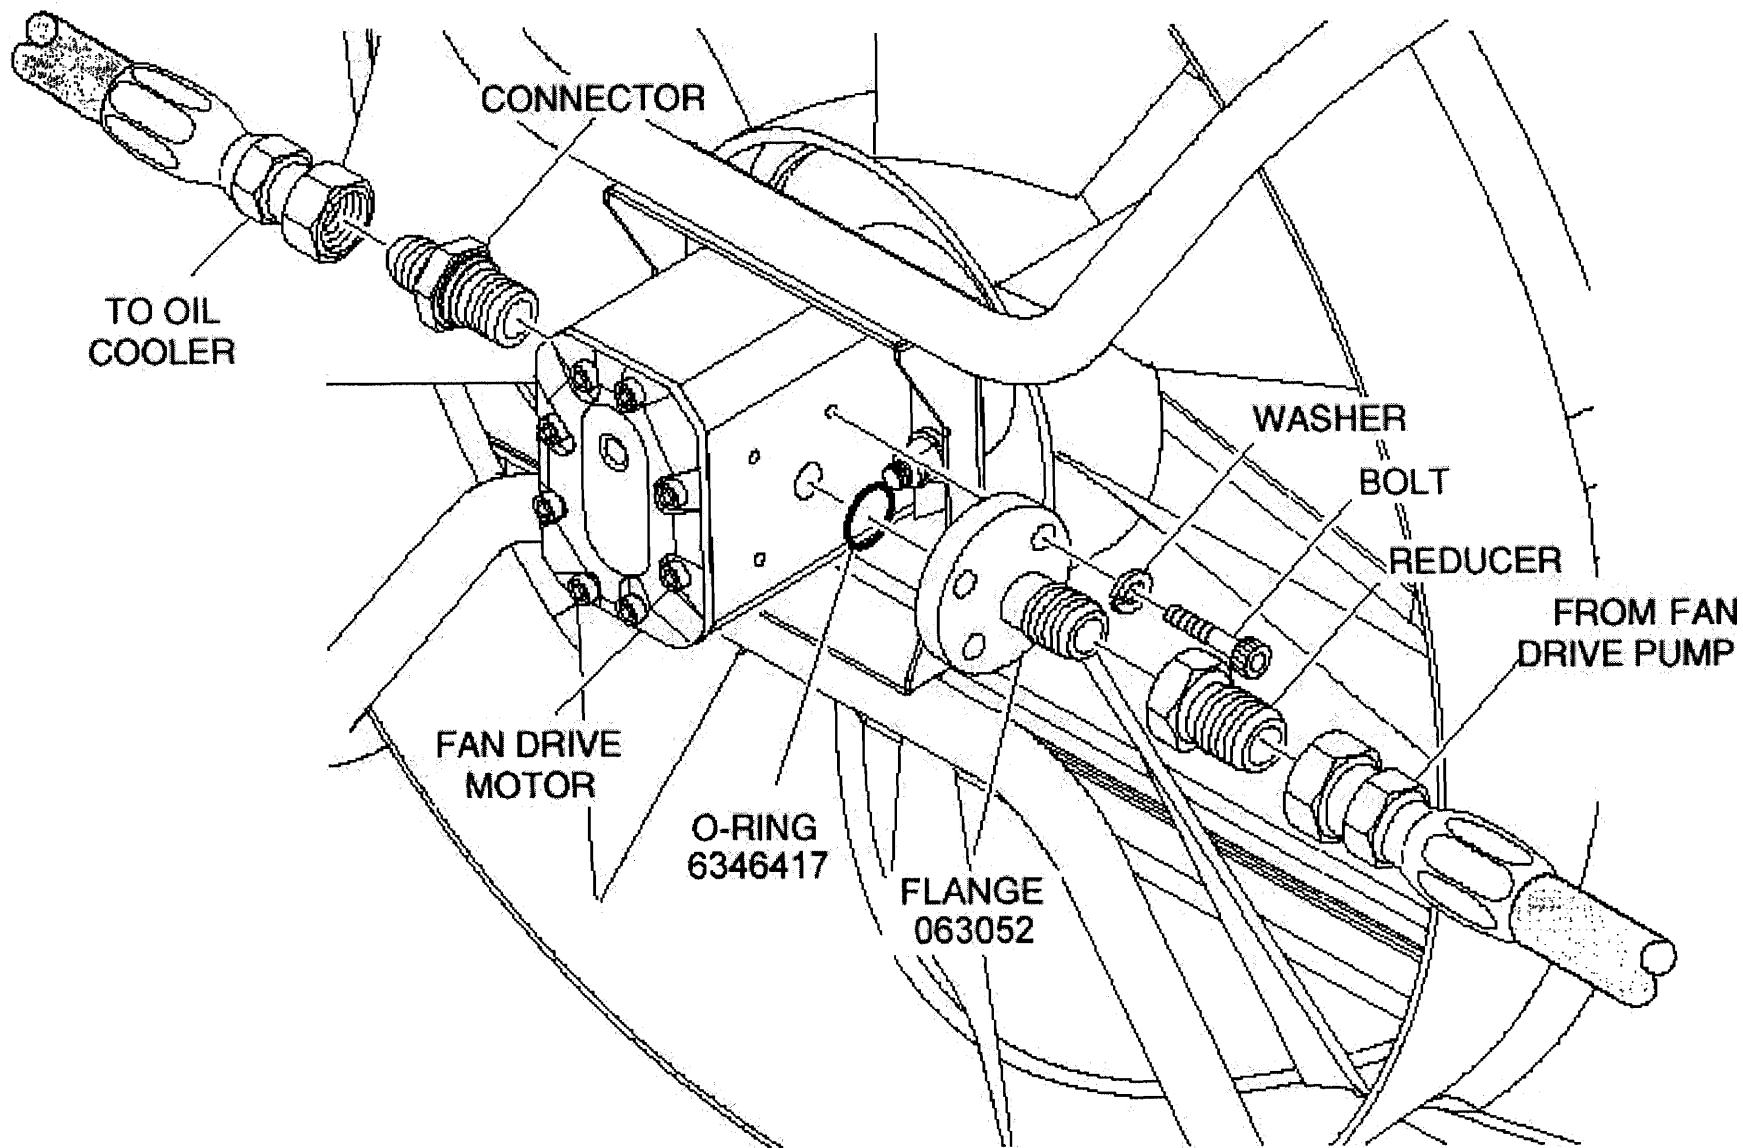
A hydraulic four bolt flange assembly (PN063052) designed to incorporate an O-ring (PN6346417) for sealing purposes was improperly torqued (see attached drawing "Component Identification.jpg"). The result is the flange seal leaks hydraulic fluid. The subject components have a high "infant mortality" rate with failures typically occurring within the first 1000 miles (discovered during factory road testing).

Torque procedures and installation instructions unavailable to production personnel. The O-ring becomes damaged during the tightening of the flange fitting bolts as it is pinched between the two mating surfaces. Damage to the O-ring compromises the seal allowing hydraulic fluid to escape.

(b) Hydraulic fluid evident below the flange assembly on fan motor housing is an indication of damage and the failure of the O-ring to seat.

Flange manufacture will replace all assemblies in the field which were installed since October 2004 with a new component being offered as a product improvement.

Remedy assembly has the proper O-ring groove volume to create a positive seal and specific torquing instructions. Instruction will also be included in the after-market assembly kit.
