**Re: Defect Information Report FL-452, ZF Steering Shaft**

## Defect Information Report

### Part 573 Notification to NHTSA

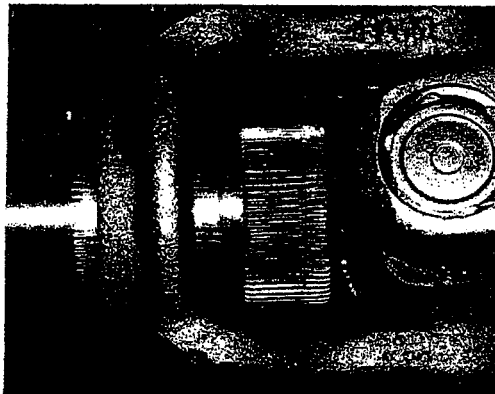
The I-Shaft is the mechanical linkage between steering wheel and the steering gear. At the non welded side of the I-Shaft there is the universal joint. There are possibilities that the fork / shaft connection may get lost.

Employee failure: The Fork was broached twice. Consequently the press fit connection between the Fork and the Shaft may get lost.

In case of fork / shaft connections get lost the steering ability of the vehicle gets lost.

100% control of force and stroke during press fit connection fork / shaft, starting October 20<sup>th</sup>, 2004.

Verification of parts with special created tool (parts with less than 13kN pull-of force will be clearly identified as beyond specification and automatically destroyed).

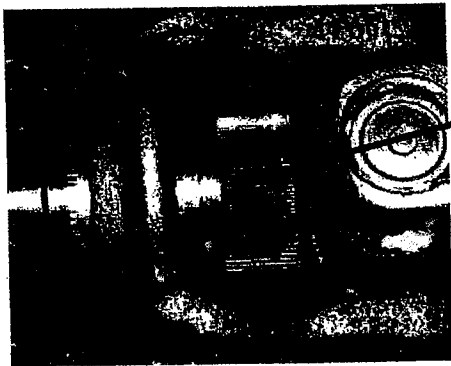
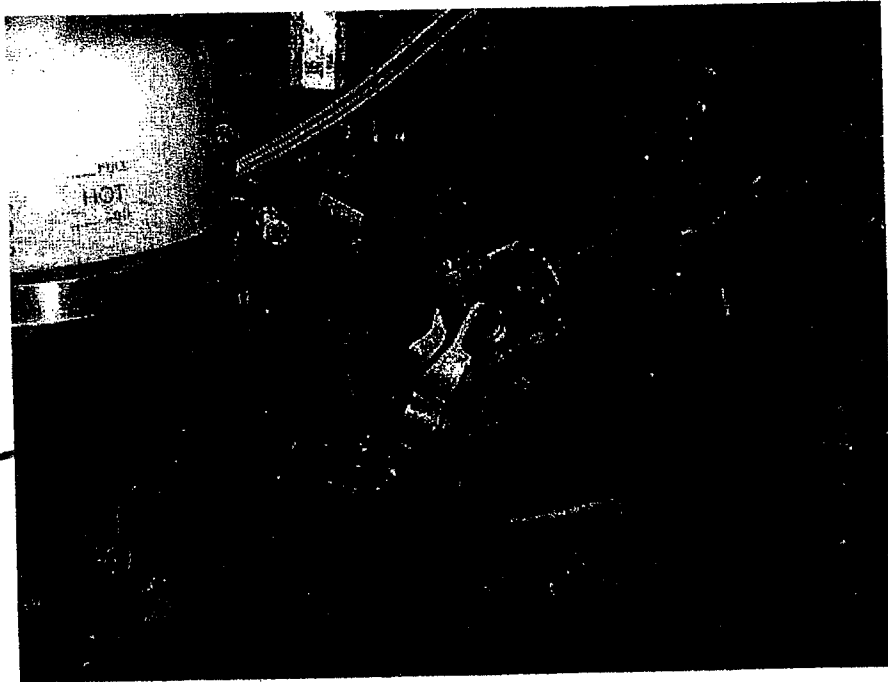
The steering wheel was suddenly free to turn while breaking the vehicle had a collision with the road shoulder guard rail.

The driver lost the steering control because the shaft of the I-shaft unit slit into the press-on fork.
