Re: Defect Information Report

05V-409
(11 pages)

Defect Information Report

SUBJECT: BRAKE MASTER CYLINDER REPLACEMENT — SAFETY RECALL CAMPAIGN		No: SR-05-005	
		DATE: September, 2005	
		MODEL: 2005 Galant, Endeavor	
CIRCULATE TO:	<input type="checkbox"/> GENERAL MANAGER	<input checked="" type="checkbox"/> PARTS MANAGER	<input checked="" type="checkbox"/> TECHNICIAN
<input checked="" type="checkbox"/> SERVICE ADVISOR	<input checked="" type="checkbox"/> SERVICE MANAGER	<input checked="" type="checkbox"/> WARRANTY PROCESSOR	<input type="checkbox"/> SALES MANAGER

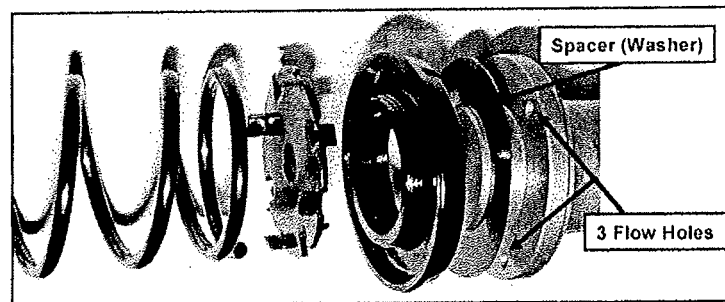
During assembly of the master cylinder, the spacer (washer) that is normally placed between the alloy master cylinder application piston and the rubber pressure cup was not installed. As a result, the rubber pressure cup in the master cylinder may become damaged and allow brake fluid to by-pass. This may result in reduced braking pressure and allow a longer than normal pedal stroke. Should this condition occur, the braking distance required to stop the vehicle will increase and may lead to a vehicle crash. Diagrams explaining the misassembled components are included at item 12.

Properly assembled piston with spacer (washer)

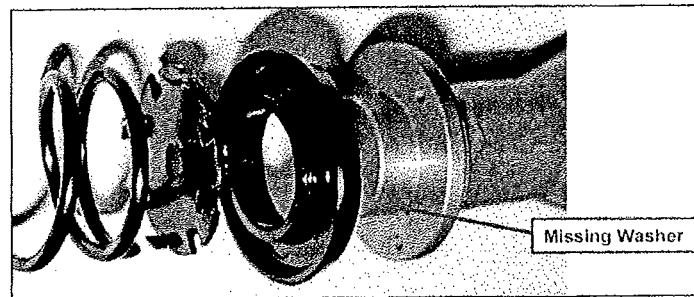
Improperly assembled piston without spacer (washer)

The owners of all subject vehicles will be notified by mail first class mail and requested to bring their vehicle back to their dealer for replacement of the master cylinder free of charge. A copy of the draft TSB and proposed letter are attached for your review and approval.
