**MITSUBISHI FUSO**

**Subject: Safety Recall Notification on the Turn Signal/Hazard Lamp Wiring Harness;  
Model Years: 2005-2006; Models: FE83D, FE84D, FE85D, FG84D  
MFTA Safety Recall – C1000210 Turn Signal/Hazard Lamp Wiring Harness  
NHTSA Safety Recall – 05V-410**

Defect and Noncompliance Information Report

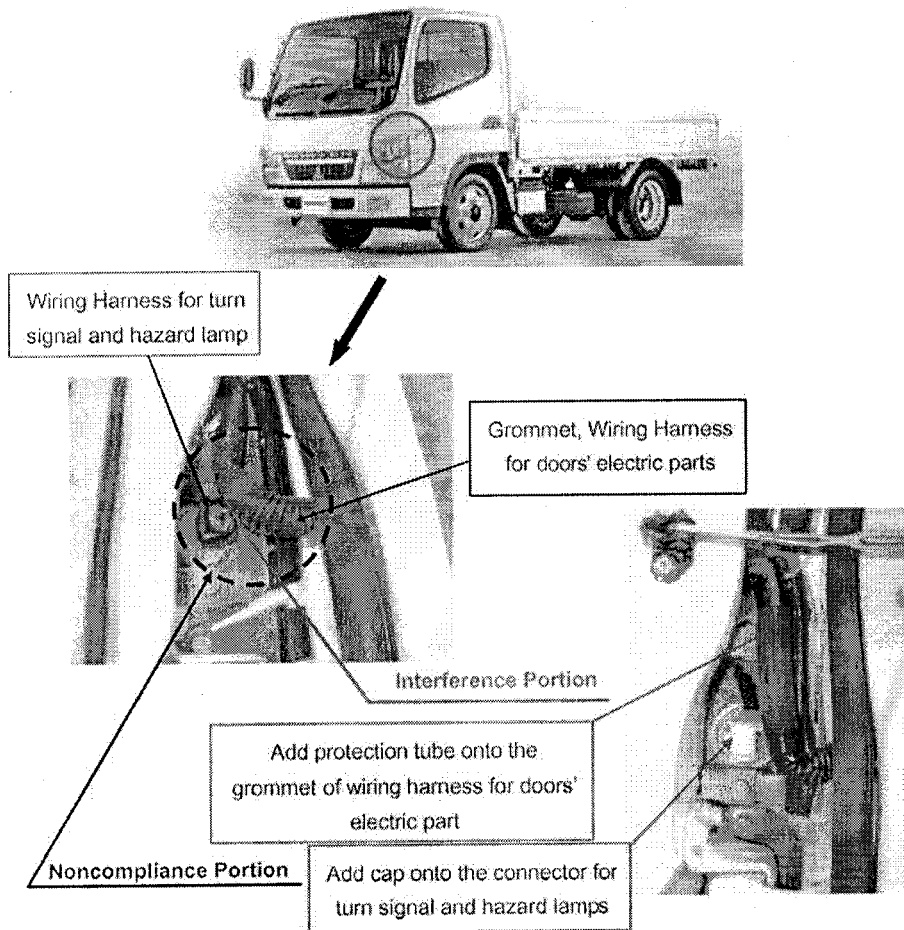
The door wiring harness interferes with the turn signal and hazard lamp wiring harness due to improper routing. Repeated opening and closing of the doors could break the turn signal and hazard lamp wiring harness, causing the lamps to become inoperative.

After deliberate study of failed sample parts, MFTBC determined that the failures were caused by interference between the door wiring harness and turn signal/hazard lamp wiring harness. Repeated opening and closing of the doors could break the turn signal and hazard lamp wiring harness, causing the lamps to become inoperative.

8. A description of the manufacturer's program for remedying the defect or noncompliance:
- Add protective tubing at the door wiring harness grommet, install a protective cap on the turn signal and hazard lamp connector and repair any wiring harness damage.
