**MITSUBISHI FUSO**

**Subject: Safety Recall Notification on the Turn Signal/Hazard Lamp Wiring Harness;  
Model Years: 2005-2006; Models: FE83D, FE84D, FE85D, FG84D  
MFTA Safety Recall – C1000210 Turn Signal/Hazard Lamp Wiring Harness**

Defect and Noncompliance Information Report

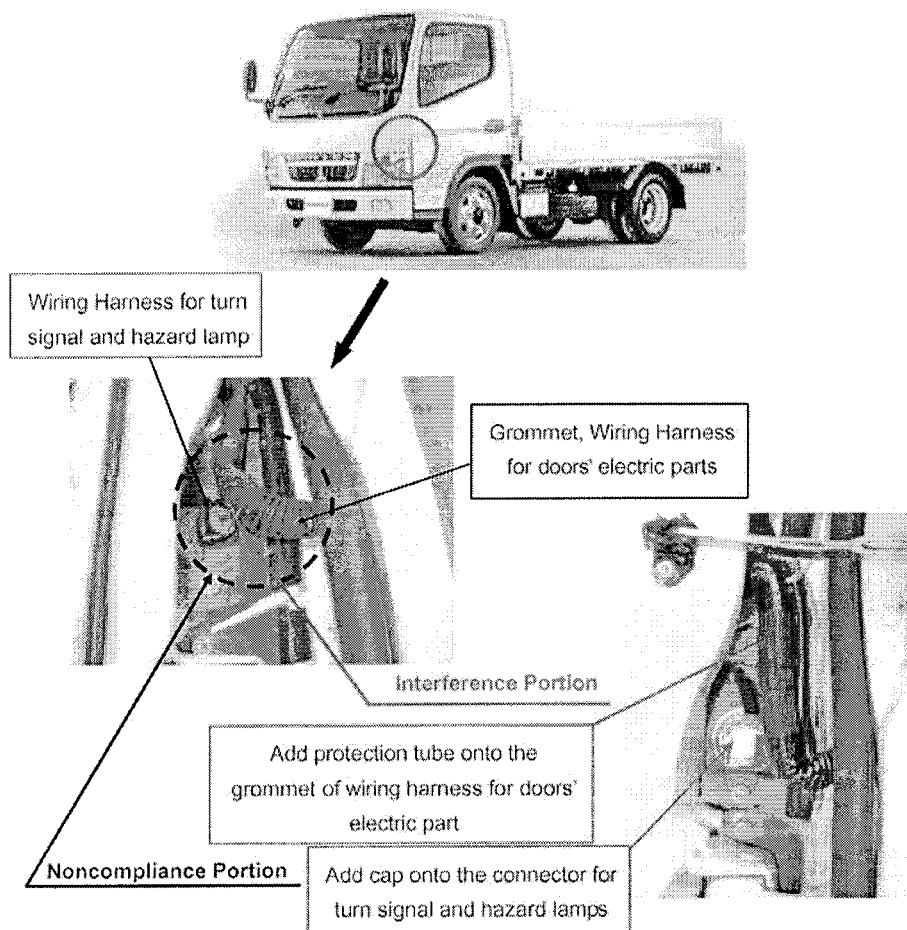
The door wiring harness interferes with the turn signal and hazard lamp wiring harness due to improper routing. Repeated opening and closing of the doors could break the turn signal and hazard lamp wiring harness, causing the lamps to become inoperative.

After deliberate study of failed sample parts, MFTBC determined that the failures were caused by interference between the door wiring harness and turn signal/hazard lamp wiring harness. Repeated opening and closing of the doors could break the turn signal and hazard lamp wiring harness, causing the lamps to become inoperative.

8. A description of the manufacturer's program for remedying the defect or noncompliance:
- Add protective tubing at the door wiring harness grommet, install a protective cap on the turn signal and hazard lamp connector and repair any wiring harness damage.
