*05V-411
(4 pages)*

**Subject: Safety Recall Notification on the 4M50 Idler Gear Bushing;
Model Years: 2004; Models: FE640, FH210
MFTA Safety Recall – R3150510 4M50 Idler Gear Bushing**

Defect and Noncompliance Information Report

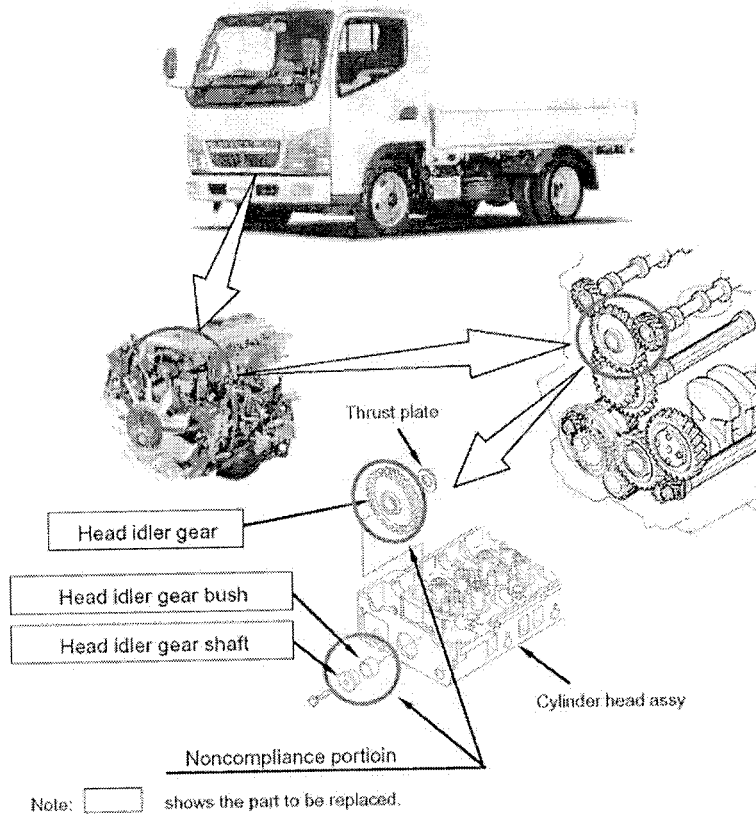
On affected vehicles, the cylinder head idler gear bushing may have been improperly machined, causing excessive stress on the cylinder head idler gear shaft. Continued operation in this condition could cause the idler gear shaft flange to break and generate abnormal engine noise and/or engine oil leaks. In the worst case, the engine could stall and would not restart.

After deliberate study of failed sample parts, MFTBC determined that the cause of failure was improperly machined cylinder head idler gear bushing. Continued operation in this condition could cause the idler gear shaft flange to break and generate abnormal engine noise and/or engine oil leaks. In the worst case, the engine could stall and would not restart.

8. A description of the manufacturer's program for remedying the defect or noncompliance:
- Measure the inside diameter of the cylinder head idler gear bushing. If the bushing is out of specification, replace the idler gear bushing, idler gear shaft and idler gear assembly.
