Re: Tuthill Transport Technologies Recall No. 0509-Certain models 20/22 AR and RS 3162 Trailer Suspensions

Subject: Tuthill Transport Technologies Recall No. 0509 – Certain Models 20/22 AR and RS3162 Trailer Suspensions – Beam/Axle Pivot Connection Joint

49 CFR PART 573 - DEFECT INFORMATION REPORT
TUTHILL TRANSPORT TECHNOLOGIES RECALL NO. 0509 - CERTAIN MODELS 20/22 AR AND RS3162
TRAILER SUSPENSIONS - BEAM/AXLE PIVOT CONNECTION JOINT

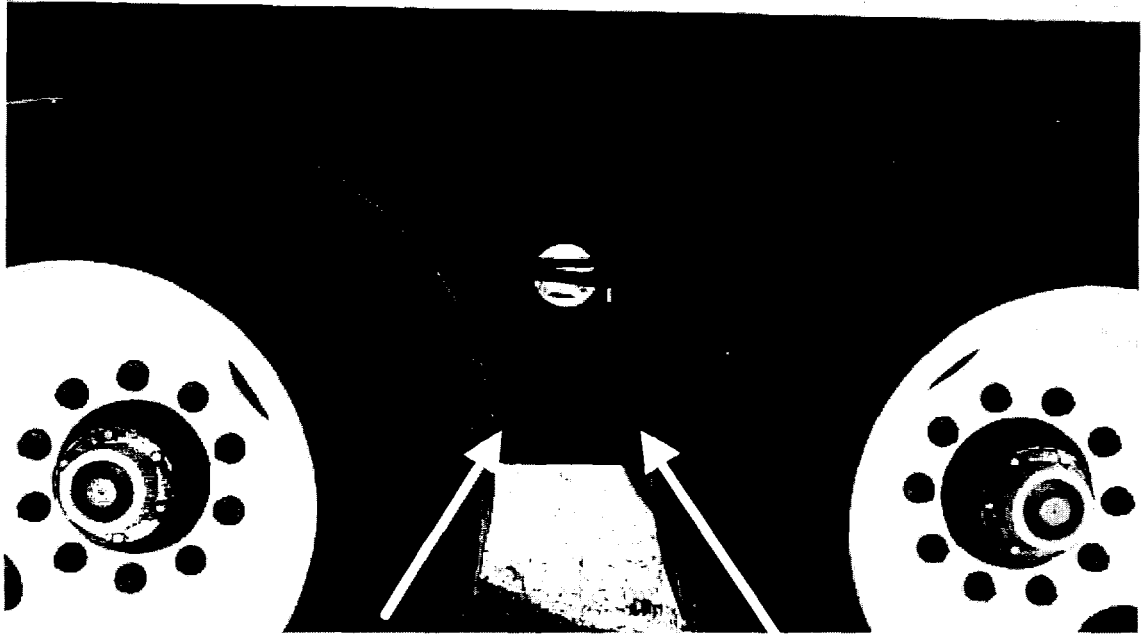
EXHIBIT A

A mis-assembled beam/axle pivot connection joint will result in excessive play, which may be evident upon a visual inspection at any beam/axle pivot connection (Exhibit A). Also, this will especially be apparent during braking and acceleration. A truck driver will notice wandering of the trailer caused by mis-alignment of one axle to the other. The trailer suspensions shipped before and after those in the recall population do not suffer this potential condition.
