Re: Recall of Cottrell C-9ENC

## **PART 573 Defect and Noncompliance Reporting**

### **Defect Report**

## Enclosed Roof Reinforcement Installation

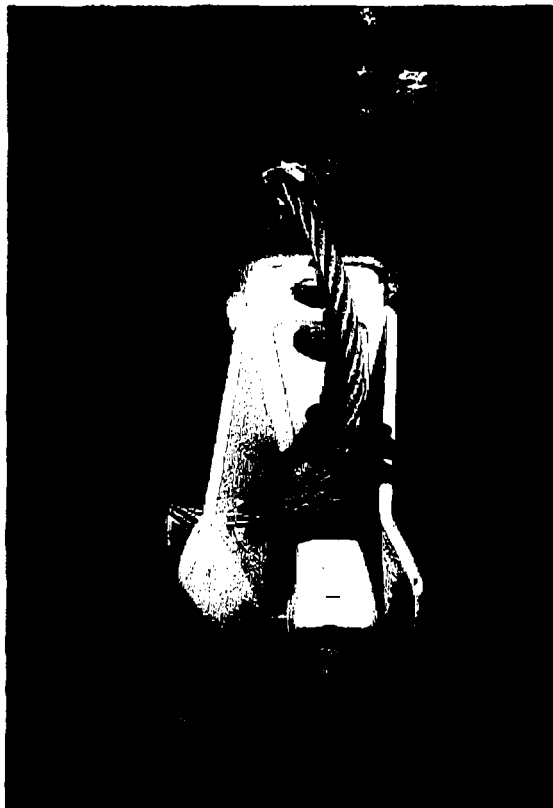
The subject vehicles are enclosed car-haul trailers that are equipped with roofs that raise and lower. The roofs are attached to a raising/lowering mechanism by brackets that are fastened to the roof. Investigation has shown that these brackets may experience high stresses during the process of seating the roof in the down position, and that the fasteners used to secure the roof to the brackets may not be able to withstand those stresses. Over time, the brackets could deform, and the fasteners may break under the stress. Should that occur, the roof might separate from the trailer. (See photographs below for a picture of the vehicle at issue and a close-up of one corner of the subject roof attachment site).

Figure 2: Close-up of one corner of the subject roof attachment site.

- a. Install 4 additional 3/8" grade 8 bolts. These bolts clamp the original roof brackets and roof between a new bottom reinforcing plate and a new top reinforcement angle.
- b. Install an extra long pin through the side of the roof.
- c. Install a safety cable between the roof and the lift bracket.
