**Re: Defect Information Report FL-464,
Fontaine Modification Sit Down Dual Drive Conversion, Steering Pinchbolt**

Defect Information Report

Ref.: Notice of Defect

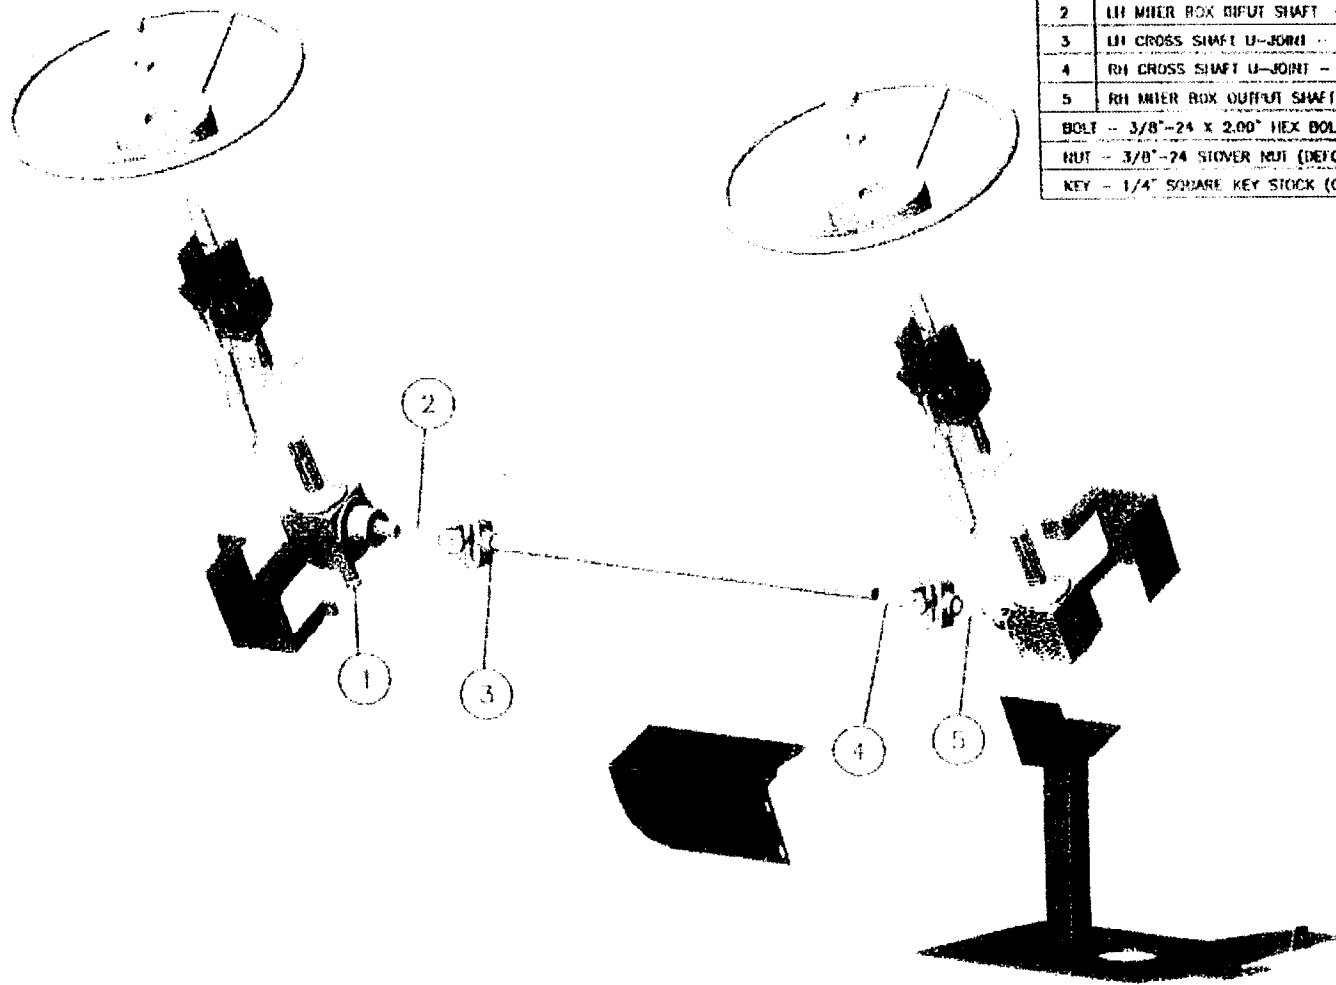
Fontaine Modification has discovered the Freightliner LH steering U-joint pinch bolt (P/N 14-15639) may have been improperly torqued on some units potentially causing the bolt to fail out. Since this defect could result in a loss of vehicle steering, all the affected vehicles need to be removed from service immediately until they can be inspected. This defect may involve as many as **102** M2 trucks built during the aforementioned period.

Attached you will find a spreadsheet detailing the **102** VIN's as well as an illustration highlighting the location (#1) of the LH steering U-joint pinch bolt.

See attached drawing – location #1. Steering U-joint pinch bolt may have been improperly installed on the collar holding the splined male and female steering shafts connecting the Fontaine Modification 3-way miter box to the vehicle steering shaft.

Steering U-joint pinch bolt was improperly torqued at time of installation.

Locate and visually inspect LH steering U-joint pinch bolt at location #1.

1. If pinch bolt and hex nut remain in place, tighten hex nut to 48.6 lb ft torque and affix colored torque seal.
2. If pinch bolt is missing, install Freightliner P/N 14-15639-000 bolt and 14-15640 hex nut in steering U-joint. Tighten nut to 48.6 lb ft torque and affix colored torque seal.

Remedy will include visual inspection and torquing to 48.6 lb ft of the steering U-joint pinch bolt plus an application of torque seal.
