05V-545
(16 pages)
EQ05-027

Safety Defect and Noncompliance Report Guide for Vehicles
PART 573 Defect and Noncompliance Responsibility and Reports¹

Subject: Tuthill Transport Technologies Recall No. 0509 - Certain Models 20/22 AR and RS3162 Trailer Suspensions - Beam/Axle Pivot Connection Joint

49 CFR PART 573 - DEFECT INFORMATION REPORT
TUTHILL TRANSPORT TECHNOLOGIES RECALL NO. 0509 - CERTAIN MODELS 20/22 AR AND RS3162
TRAILER SUSPENSIONS - BEAM/AXLE PIVOT CONNECTION JOINT

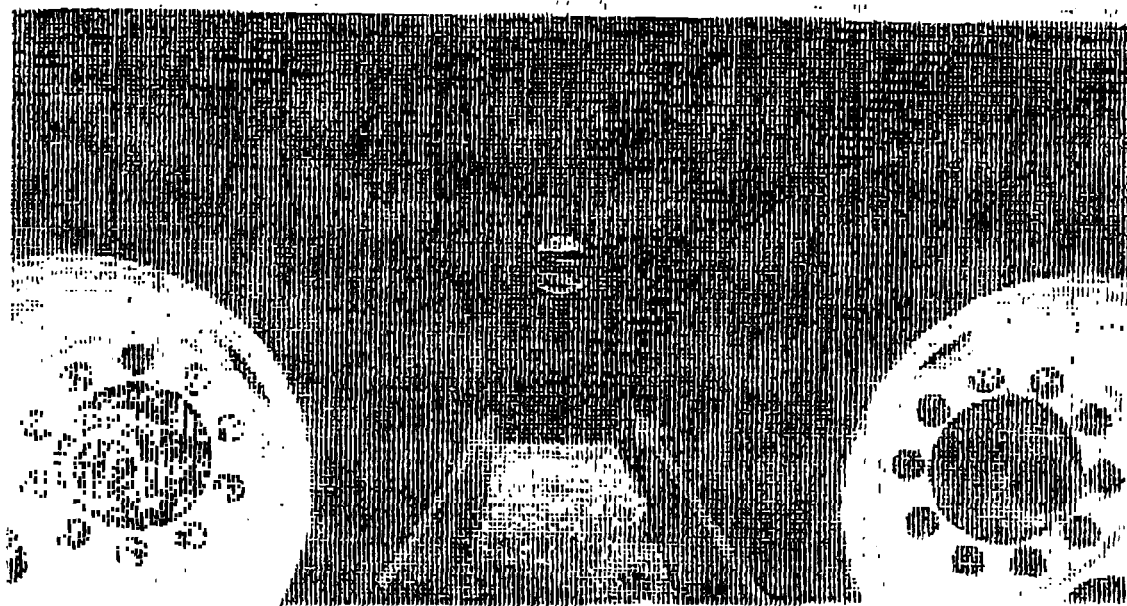
EXHIBIT A

A mis-assembled beam/axle pivot connection joint will result in excessive play, which may be evident upon a visual inspection at any beam/axle pivot connection (Exhibit A). Also, this will especially be apparent during braking and acceleration. A truck driver will notice wandering of the trailer caused by mis-alignment of one axle to the other. The trailer suspensions shipped before and after those in the recall population do not suffer this potential condition.
