AMERICAN SUZUKI MOTOR CORPORATION

DEFECT INVESTIGATION

**RE: Recall Campaign for VZ800, VL800/T/Z K5/6 Ignition Switch**

**SAFETY RECALL CAMPAIGN**  
ALL 2005 AND CERTAIN 2006 VL800/T/Z BOULEVARD C50/T  
& VZ800 BOULEVARD M50 MOTORCYCLES  
IGNITION SWITCH INSPECTION/REPLACEMENT

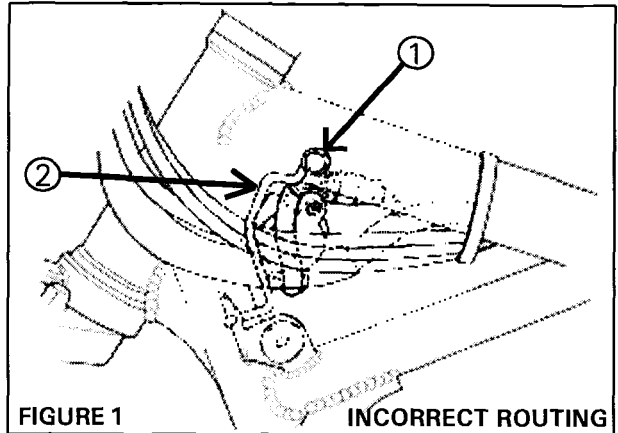
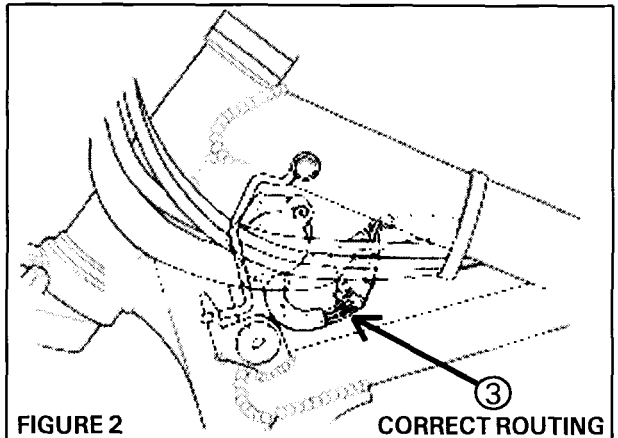
If the protective covering over the ignition switch sub-harness is cut and the insulation of the lead wires is cut and/or abraded, replace the ignition switch and lock set. (Refer to VL800 Service Manual page 8-29 and VZ800 Service Manual page 9-35 for ignition switch replacement).

3. Remove ignition key and right side frame head cover. Remove left side frame head cover.
4. Inspect the ignition switch wiring harness ③ routing. If correct, re-install the frame head covers, fuel tank and front and rear seats. Proceed to Step 7.
5. If routing is incorrect, remove guide bolt ① and guide ② only. Inspect and re-route wires as shown in Figure 2.

If the wire insulation is not cut and only the outer protective covering is damaged/cut, wrap the sub-harness with several wraps of electrical tape. In addition, if the clutch cable/throttle cable is damaged replace as necessary.

6. Re-install the cable guide, frame head covers, fuel tank and front and rear seats.
7. Turn on the ignition switch to confirm all of the electrical components are functioning properly (lights are working, engine starts and runs, etc.). Test ride the motorcycle.
8. Place an identification punch mark on the frame just after the Vehicle Identification Number per Figure 3 to confirm that the recall service has been completed. The VIN is located on the right side of the steering head pipe.
